Effectiveness of wildlife mitigation measures for turtles on Highway 69 from 2015 to 2016

Report for public dissemination

April 2017

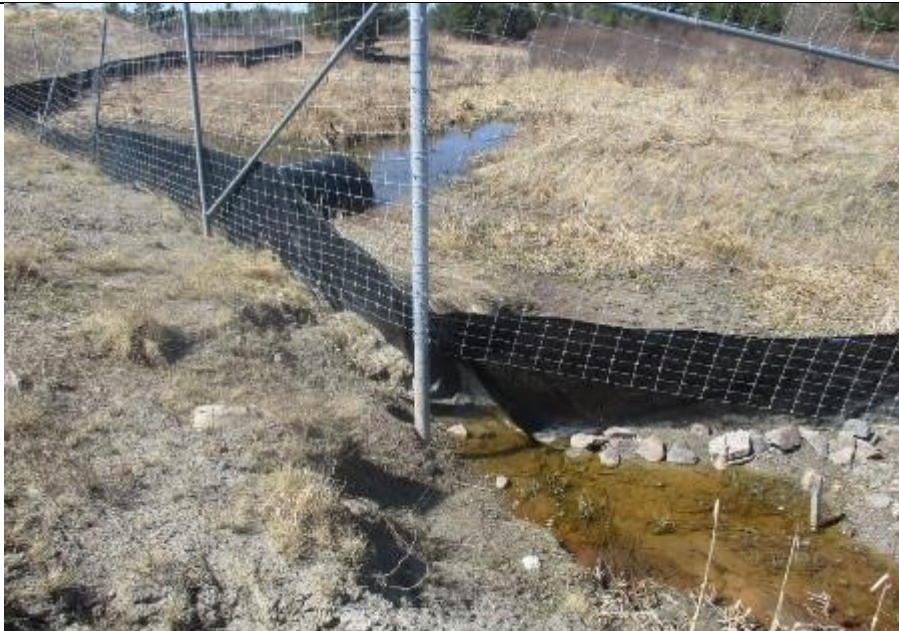
Photo 1: Drainage System 1 west end washout prior to repairs in 2016. This section of fencing also experienced a washout in 2015.

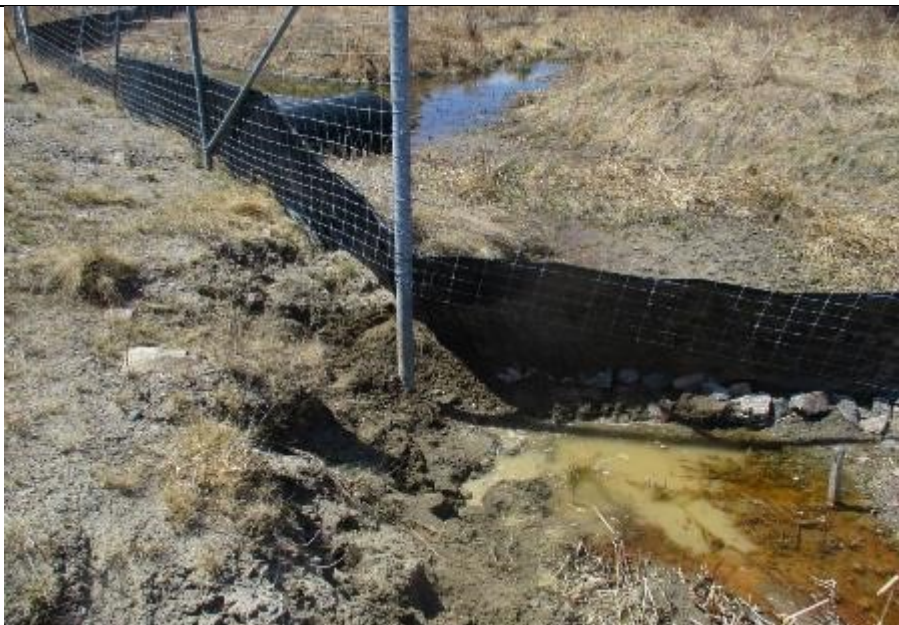
Photo 2: Drainage System 1 washout after repairs in 2016.

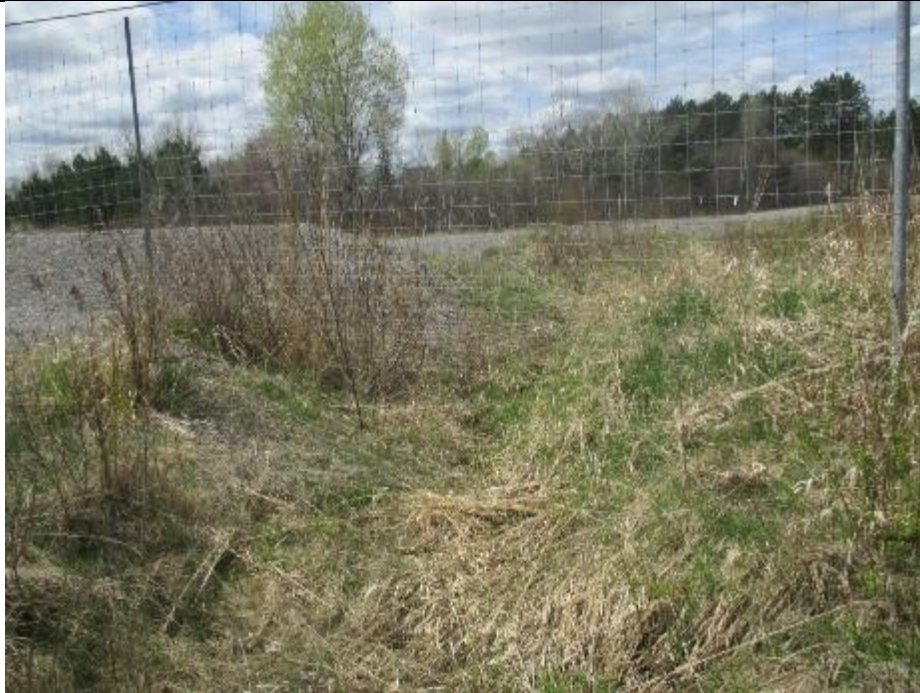
Photo 3: Gap under the large animal fencing between Drainage System 2 and Drainage System 3 in 2015.

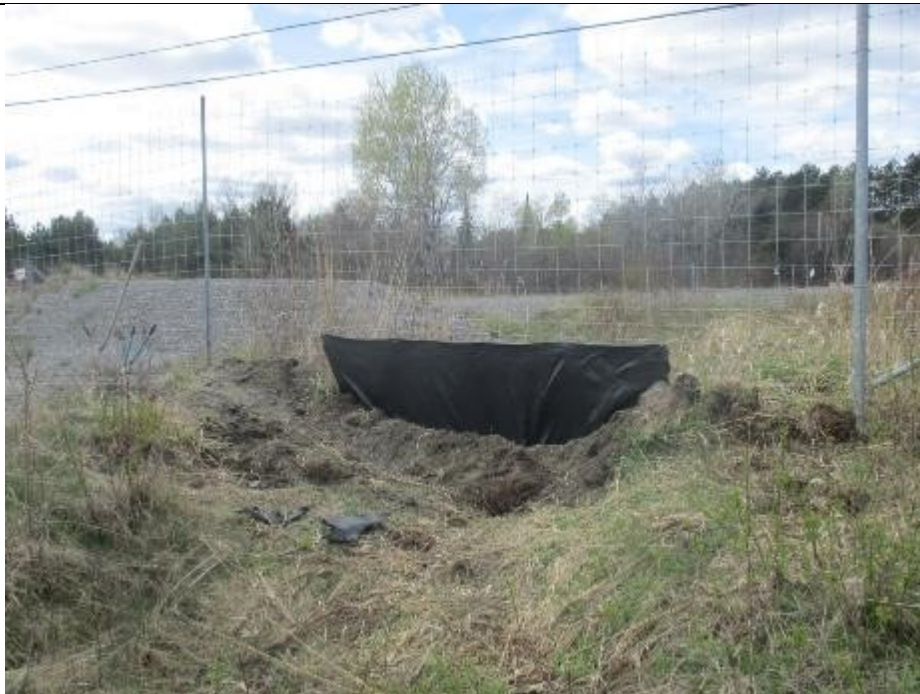
Photo 4: A five meter piece of geotextile material installed in 2016 to close the gap under the fencing between Drainage System 2 and Drainage System 3.

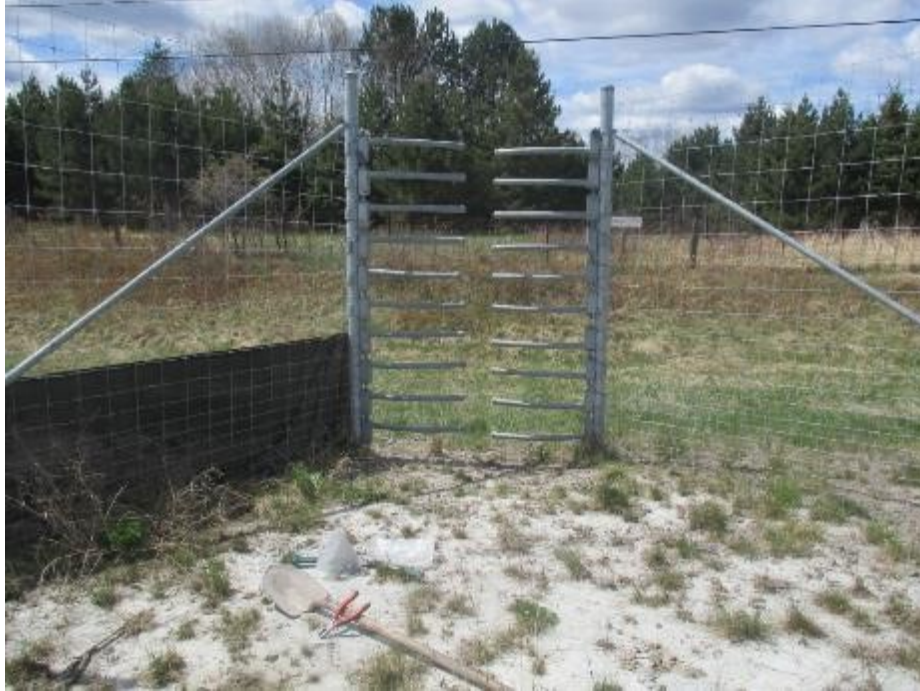
Of the six turtles found on the Sheppard Lake transect in 2015, three (one Blanding's, one Painted and one Snapping Turtle) likely breached the southwest end of the reptile exclusion fence as all were found within 150 m of the fence end (Figure 2). The other three turtles found at Sheppard transect were three juvenile Snapping Turtles that likely entered the highway on the west side where the reptile exclusion fence was no longer continuous with the primary fenced section (Figure 2). Only large animal fencing had been installed along these open sections, which permitted the juvenile turtles to breach the fence through the mesh material. In addition, the two northernmost Snapping Turtles were found at Drainage System 3, where a one-way gate had not been closed with reptile exclusion fencing (Photo 5).

Photo 5: Open one-way gate on the west side of Highway 69, between Drainage System 2 and Drainage System 3 (2015).

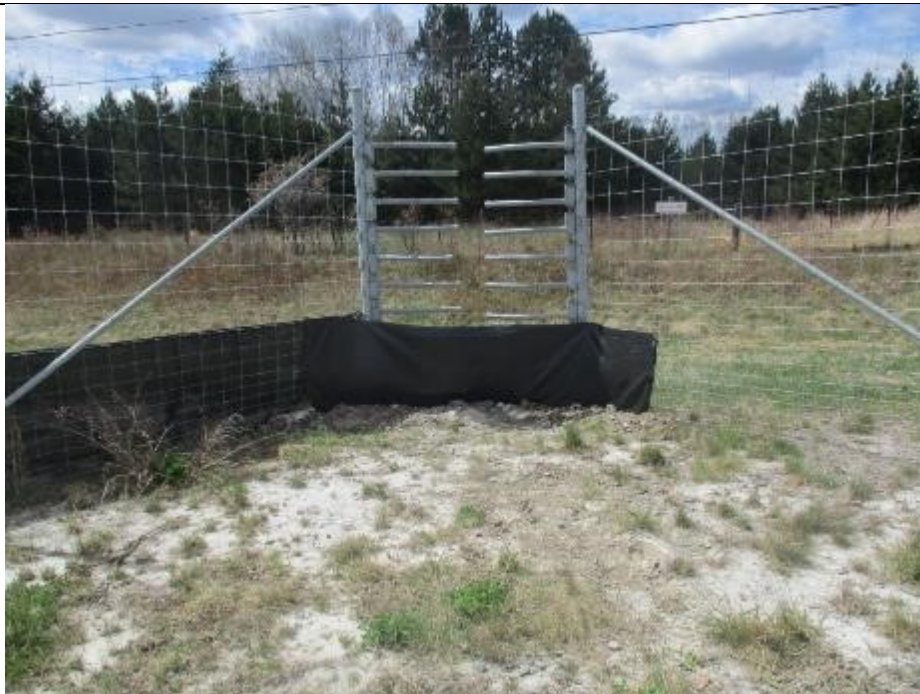
Photo 6: Closing the one-way gate between Drainage System 2 and Drainage System 3 with geotextile material (2016).

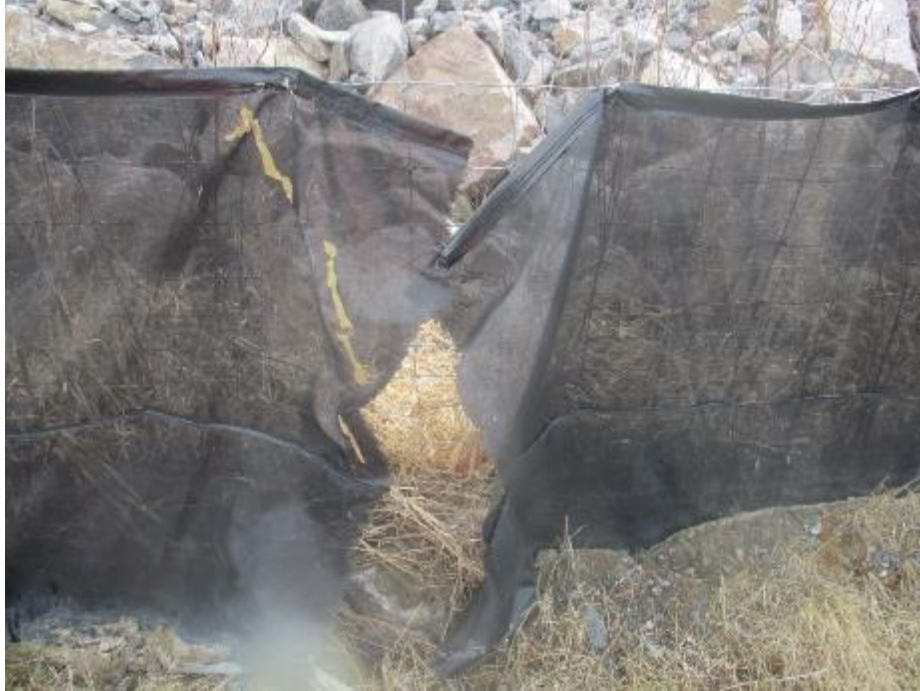
Photo 7: A rip in the reptile exclusion fencing on the west side of Highway 69 between Reptile Tunnel 1 and the northwest fence end (2016).

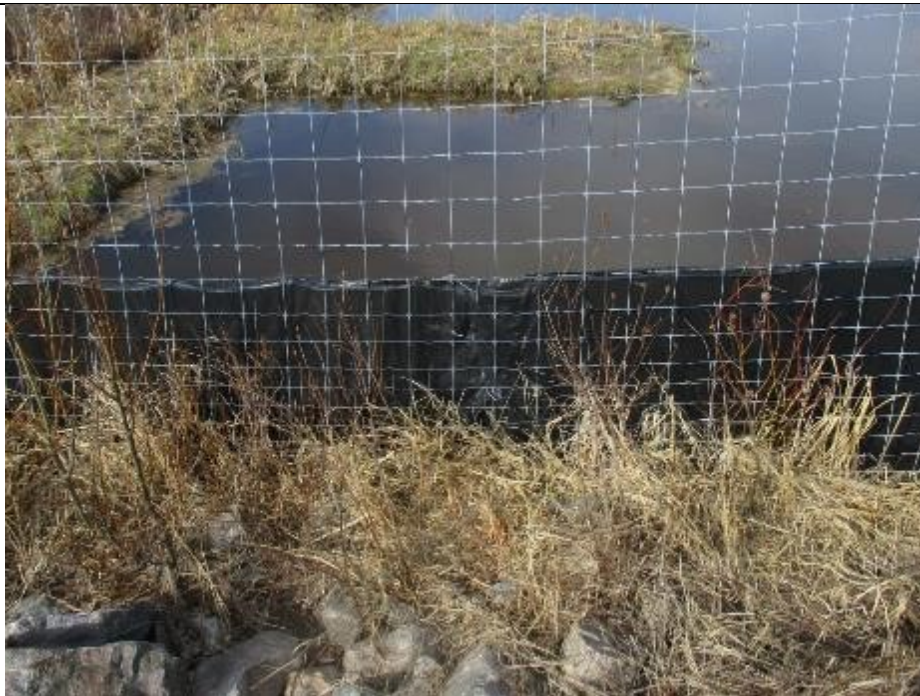
Photo 8: Repaired rip in the fencing between Reptile Tunnel 1 and the northwest fence end (2016).

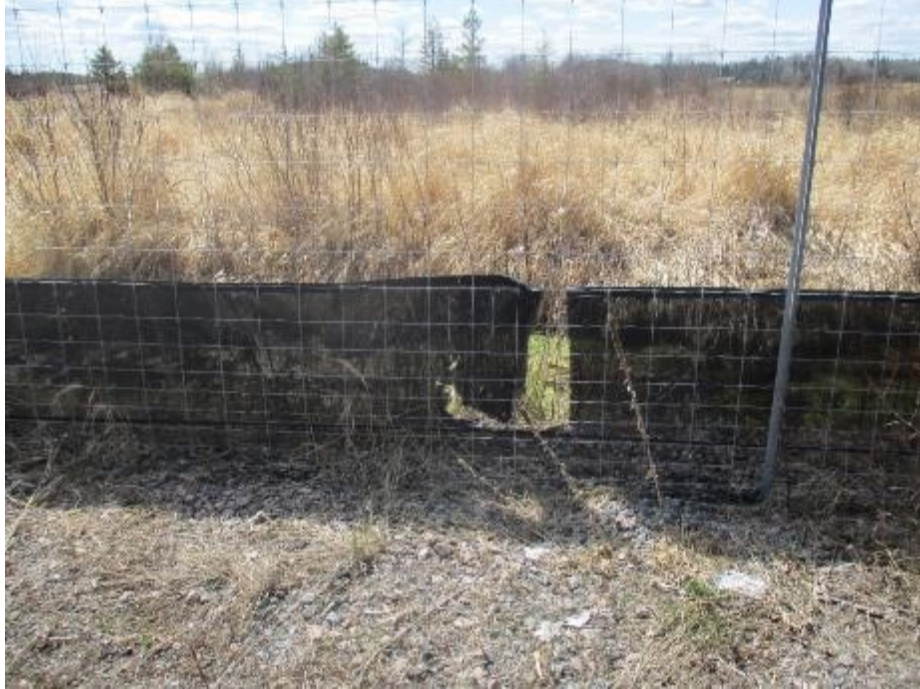
Photo 9: A second rip in the reptile exclusion fencing on the west side of Highway 69, between Reptile Tunnel 1 and the northwest fence end.

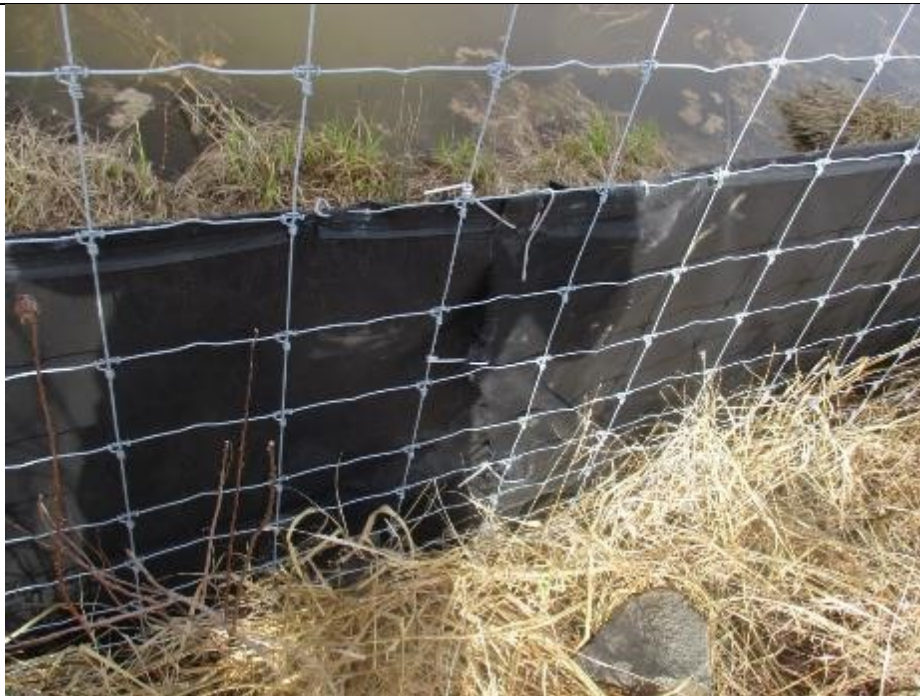
Photo 10: Second rip repaired between Reptile Tunnel 1 and the northwest fence end (2016).

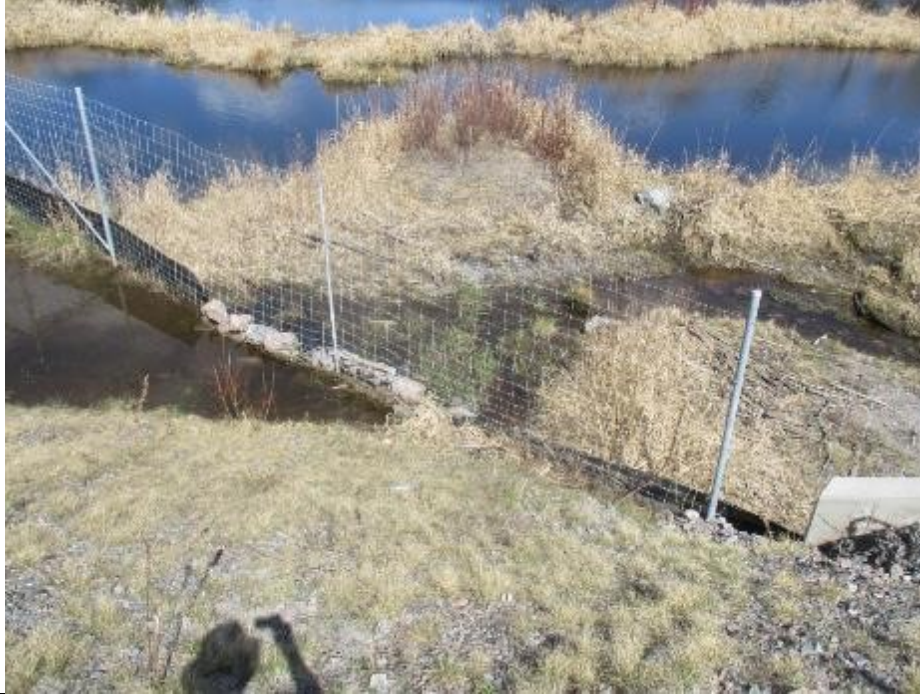
Photo 11: Change in hydrology at the Reptile Tunnel 1 east entrance. Water had flattened the reptile exclusion fencing in 2015. Fence was cut and rocks were used as barrier to exclude turtles but allow water flow, this was maintained in 2016.

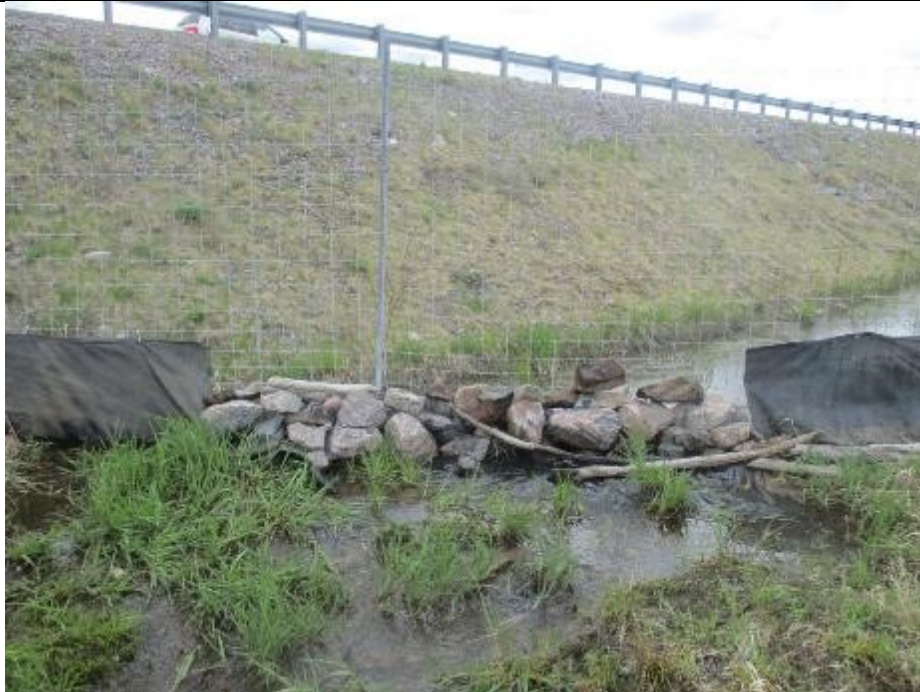
Photo 12: Zoom-in of rock wall that permits water flow built in 2015 and repaired in 2016, at the east entrance of Reptile Tunnel 1.

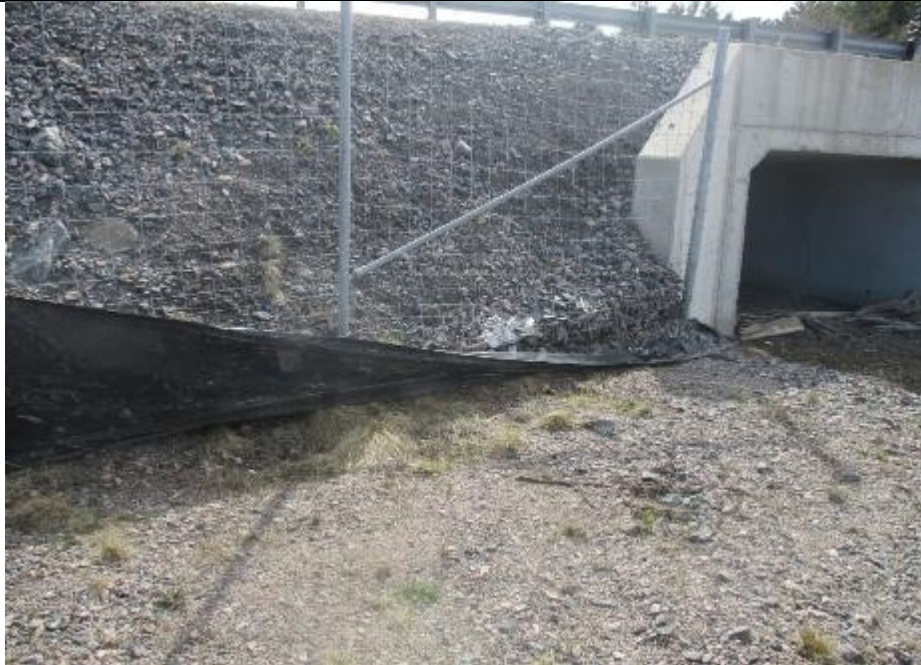
In 2015, fence maintenance occurred between May 5th and May 14th and in 2016, between May 2nd and May 3rd. See Appendix H for a detailed summary of the maintenance. There were few holes and tears in 2015. In 2016 there were three vertical tears or gaps that were patched to avoid further deterioration (Photo 7; Photo 8). In 2015, the majority of the maintenance entailed elevating the fence higher than existing water levels at each drainage system (DS) entrance and stabilizing posts in the medians and using large rocks to ensure fencing is flush to the ground (Appendix H). In both 2015 and 2016, routine maintenance entailed filling in a reoccurring wash-out at DS 1 (Photo 1; Photo 2), ensuring the fence was buried, closing all one-way gates along or at fence ends (Photo 5; Photo 6), reattaching sections of reptile fence to the large animal fence (30 to 100 m), as well as ensuring fencing securely abutted all culvert and reptile tunnel entrances (Photo 13, Photo 14, Appendix H).

Photo 13: Fallen exclusion fencing due to rip rap erosion at the east entrance of Reptile Tunnel 2 (2016).

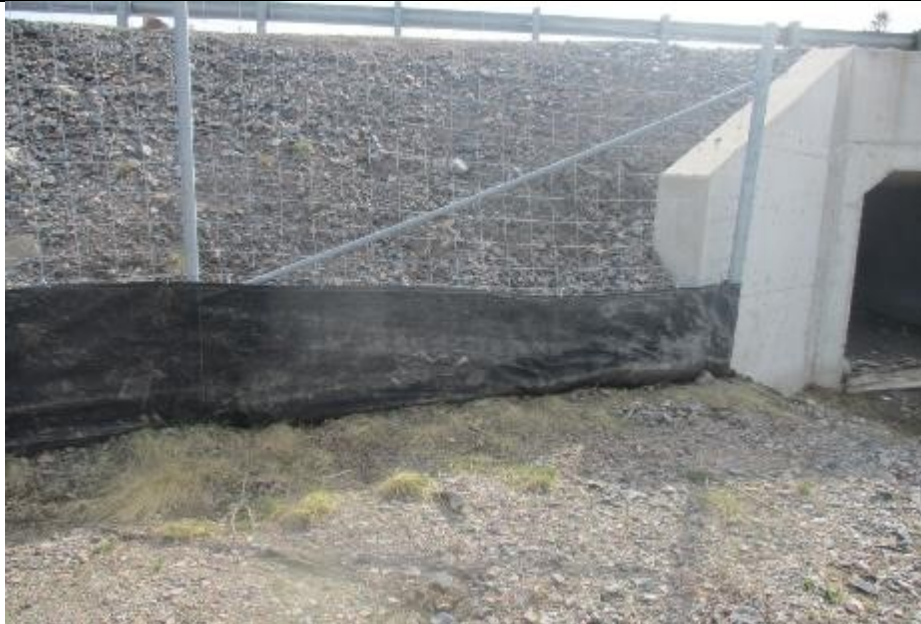
Photo 14: Repaired exclusion fencing at the east entrance of Reptile Tunnel 2 (2016).

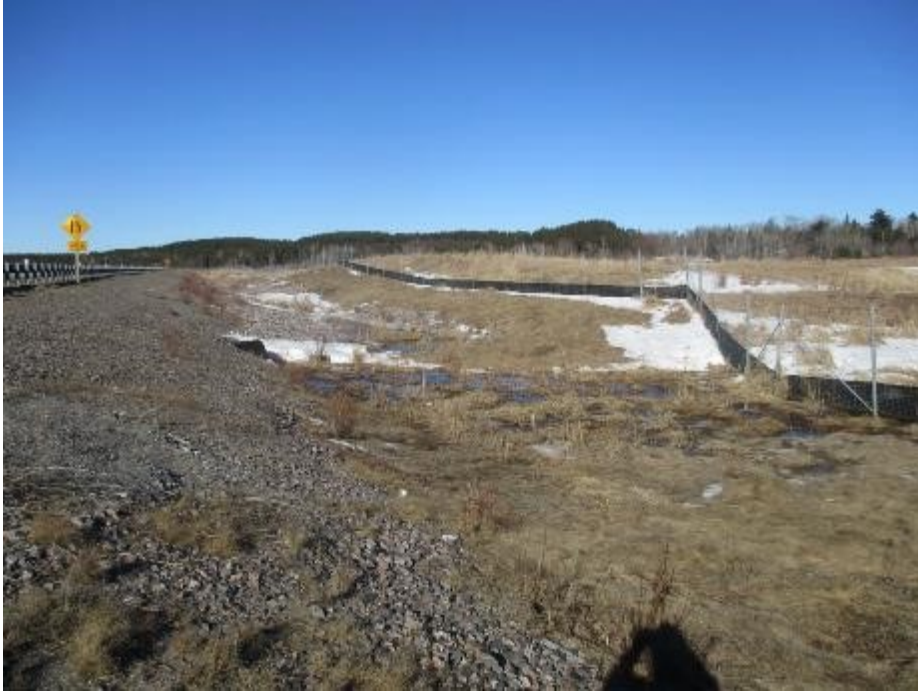
Photo 15: Non-functional drainage culvert (DS1) for wildlife passage because east end not extending through wildlife fencing.

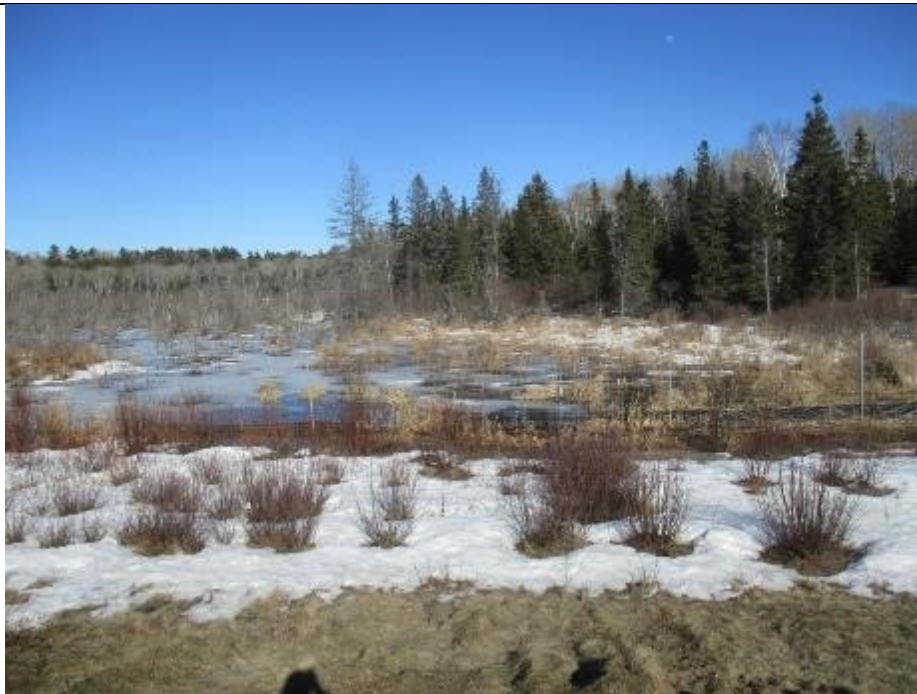
Photo 16: Water levels higher than reptile exclusion fencing at wetland habitat 700 m south of NE fence end.

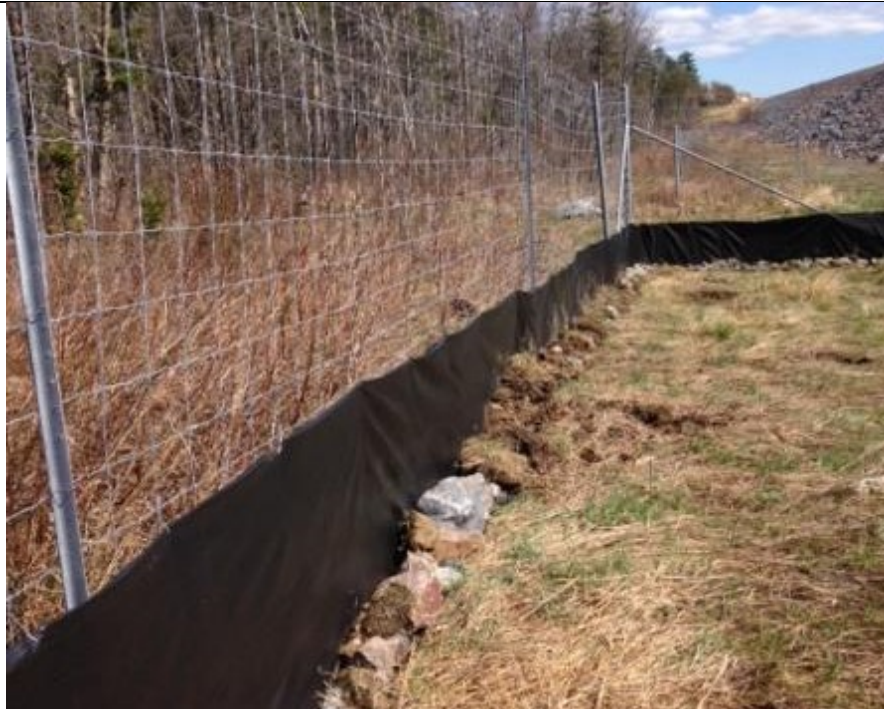
Photo 20: Completed reptile exclusion fencing at the east side of the large animal underpass; this location was the end of the Sheppard Lake transect in 2016.

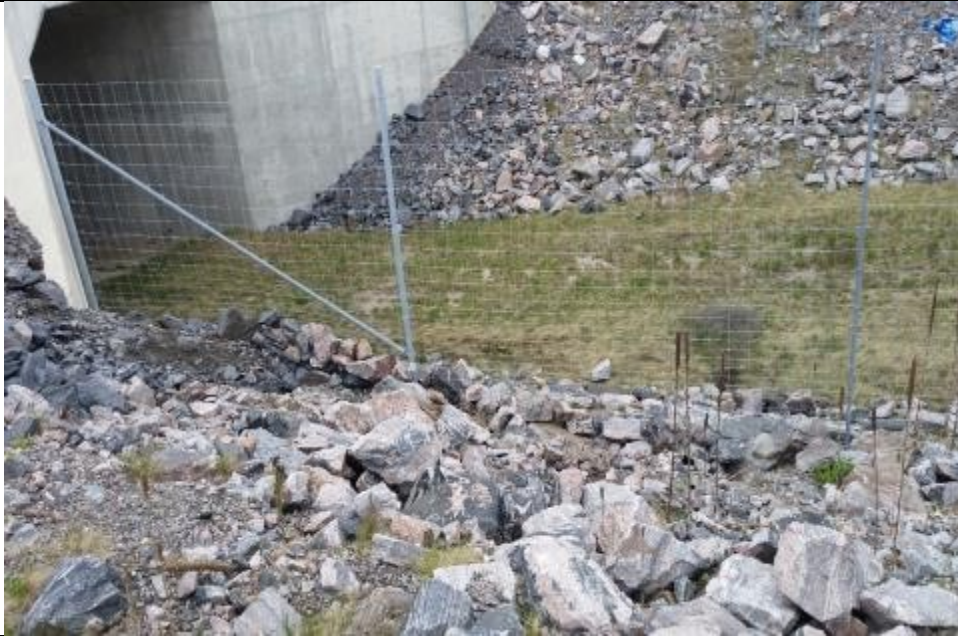
Photo 21: Large rocks stacked along the bottom of the fence to close gaps in the large animal underpass median (2016).

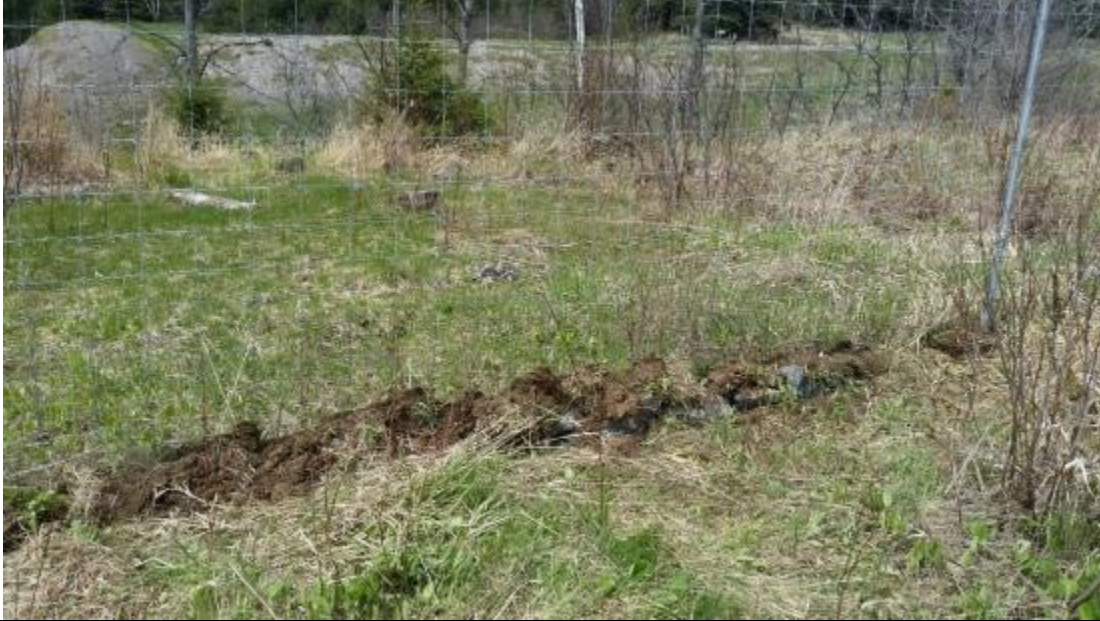
Photo 23: Rocks and dirt used to fill gaps at bottom of fence at northwest fence extension (16-May-2016).

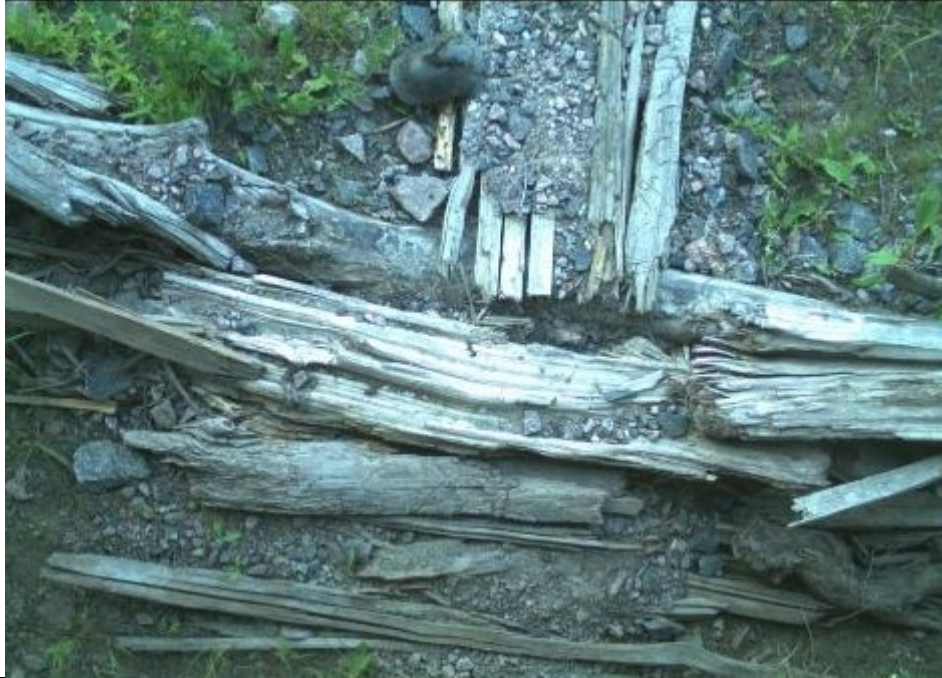
Photo 38: Painted Turtle climbing ramp into Reptile Tunnel 2 (16-June-16)

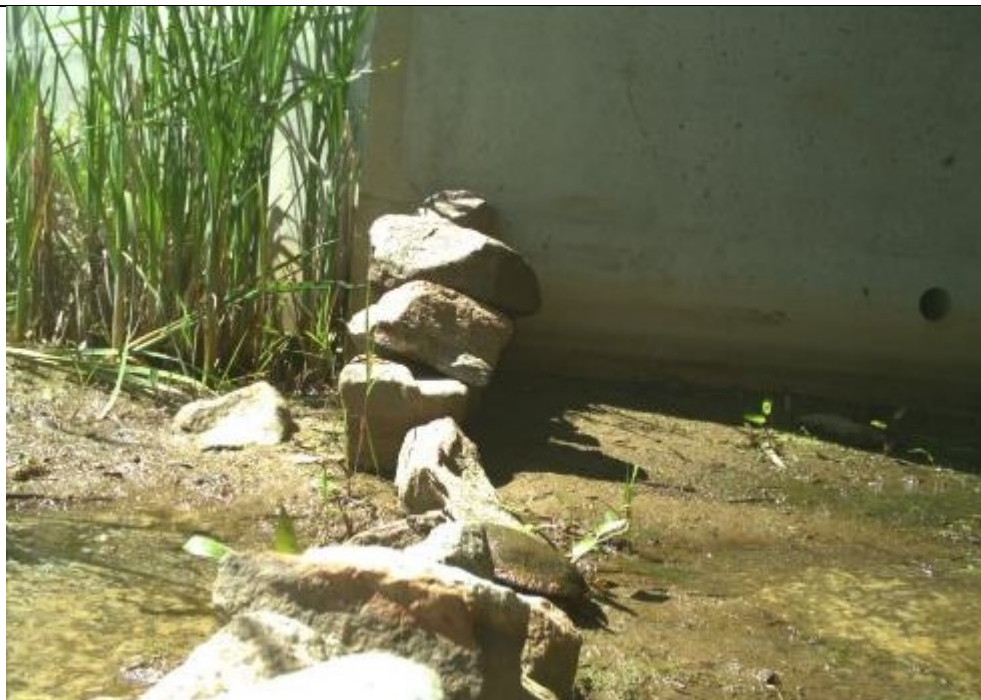
Photo 39: Painted Turtle climbing rock barrier to exit Reptile Tunnel 3E (17-June-16)
