# Effectiveness of wildlife mitigation measures for large- to mid-sized animals on Highway 69 and Highway 11 in MTO Northeastern Region, Ontario

September 2011  
to  
November 2016

**Final Report**

**June 2017**

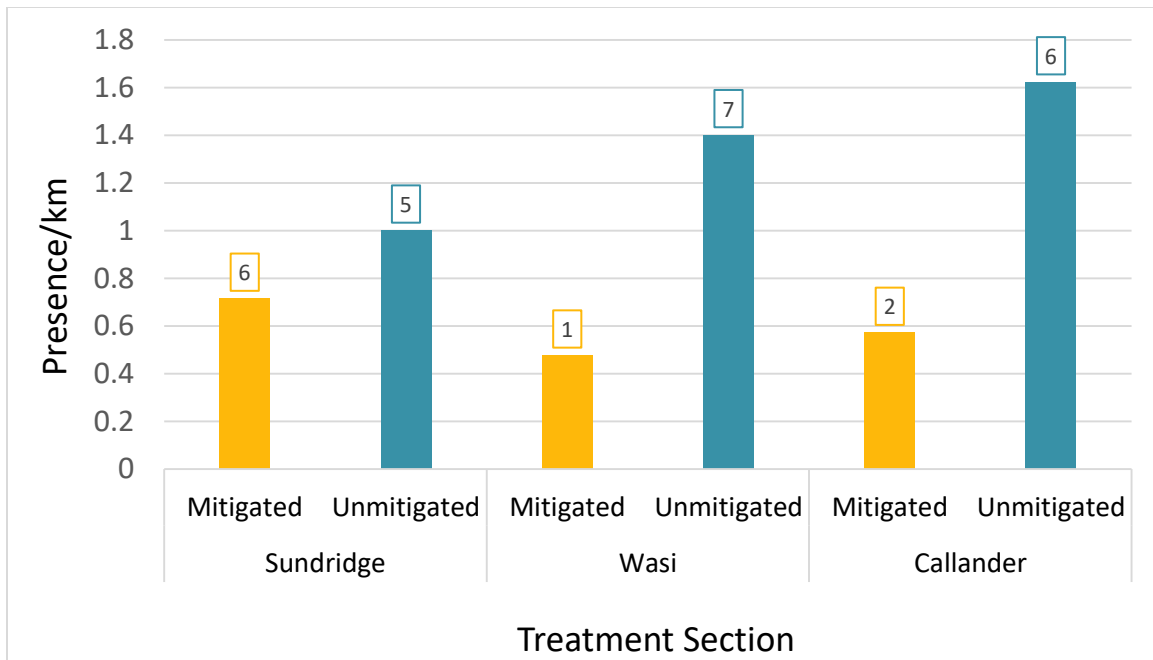
**Figure 3: Deer presence per kilometre of surveyed road at paired mitigated and unmitigated sections of Highway 11. The numbers above the bars represent the absolute number of presence detected in each section**

While mitigated treatment sections showed lower values of deer road-side presence (presences/km, Figure 3), most notably at the Wasi section, this relationship was not significant ( $t = -3.1837$ ,  $df = 2$ ,  $p = 0.086$ ). This lack of significance may be due to the lower sample size, as well as only one unmitigated control section used for comparison with each mitigated section. A replication of mitigated and unmitigated sections are ideal for rigorous evaluation using ACI or BACI analyses (Roedenbeck et al. 2007). Future studies could include multiple adjacent transects both north and south of the mitigated zones. In addition, with multiple years of data snow-tracking may prove to be a reliable estimator of the effect of mitigation at excluding animals from the road-sides.

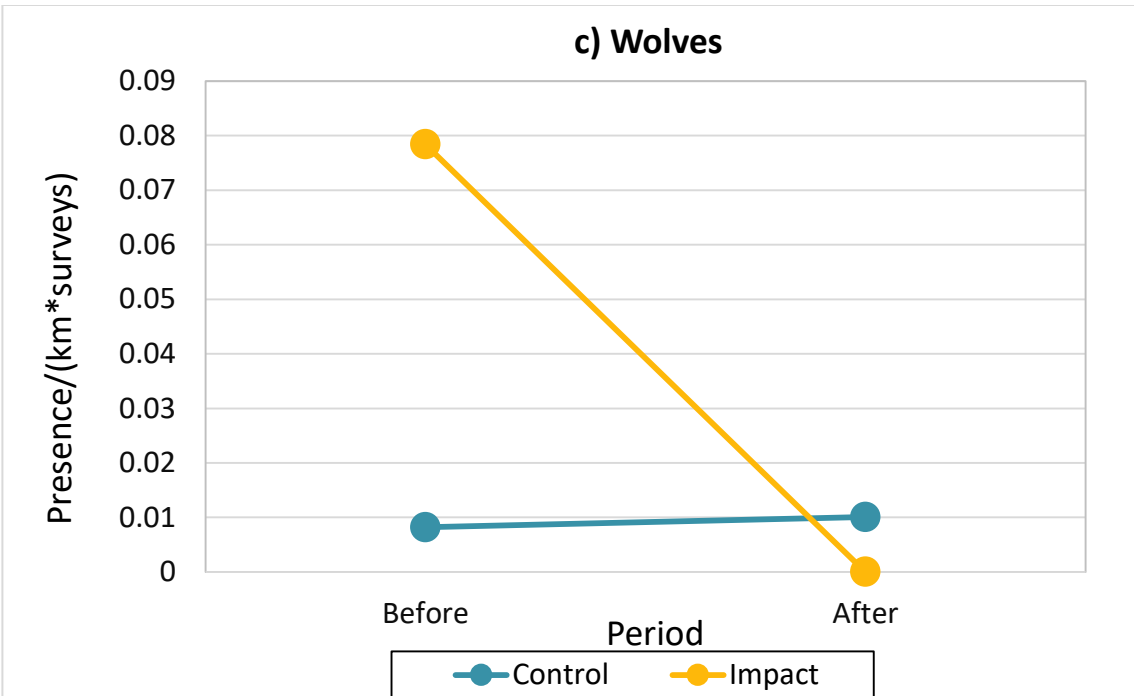
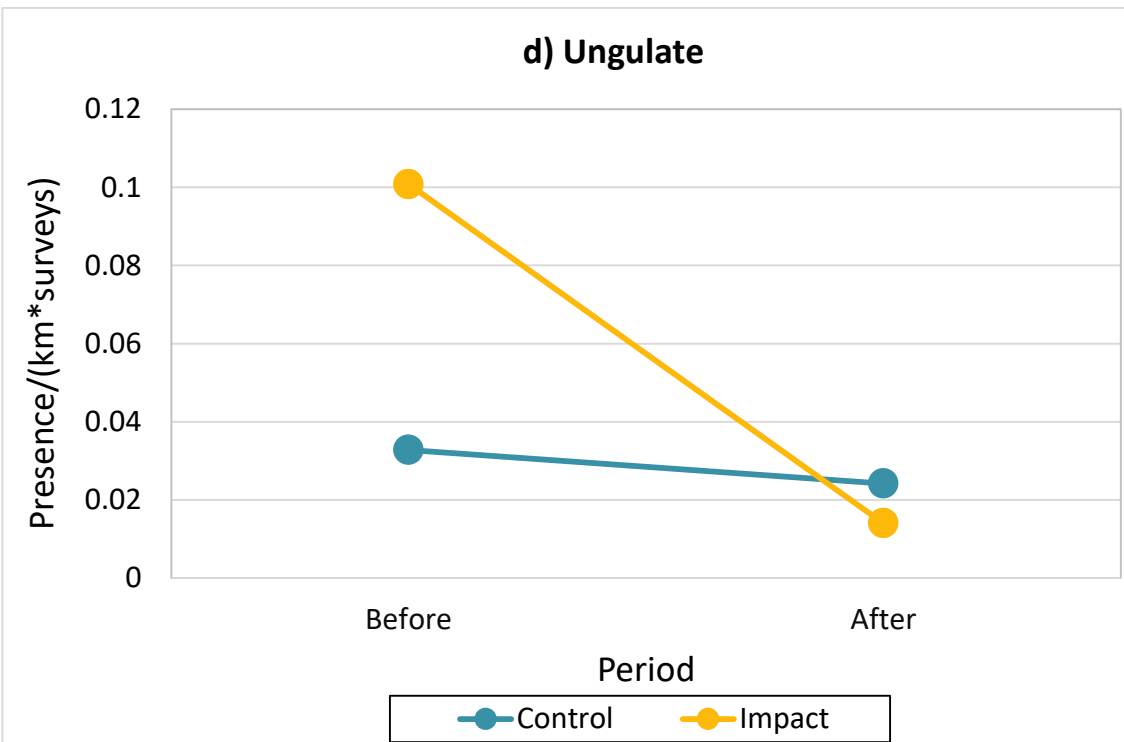
**Figure 5: Mean presence per kilometre of surveyed road standardized for sampling effort (presence/(km\*surveys)) during the before and after periods at the Control (Trout Lake Road to Makynen Rd) and Impact (Old Hwy 69/Hwy 69 New Alignment) sections on Highway 69 using snow-tracking data.**

The one sample t-tests that compared the difference in road-side presence between the mitigated (Impact) and unmitigated (Control) sections varied significantly between the before and after periods for deer ( $t_2 = -4.86$ ,  $p = 0.040$ ; Figure 5a), moose ( $t_2 = 6.37$ ,  $p = 0.024$ ; Figure 5b), wolves ( $t_2 = 7.96$ ,  $p = 0.015$ ; Figure 5c) and the ungulate group ( $t_2 = 12.21$ ,  $p = 0.007$ ; Figure 5d).

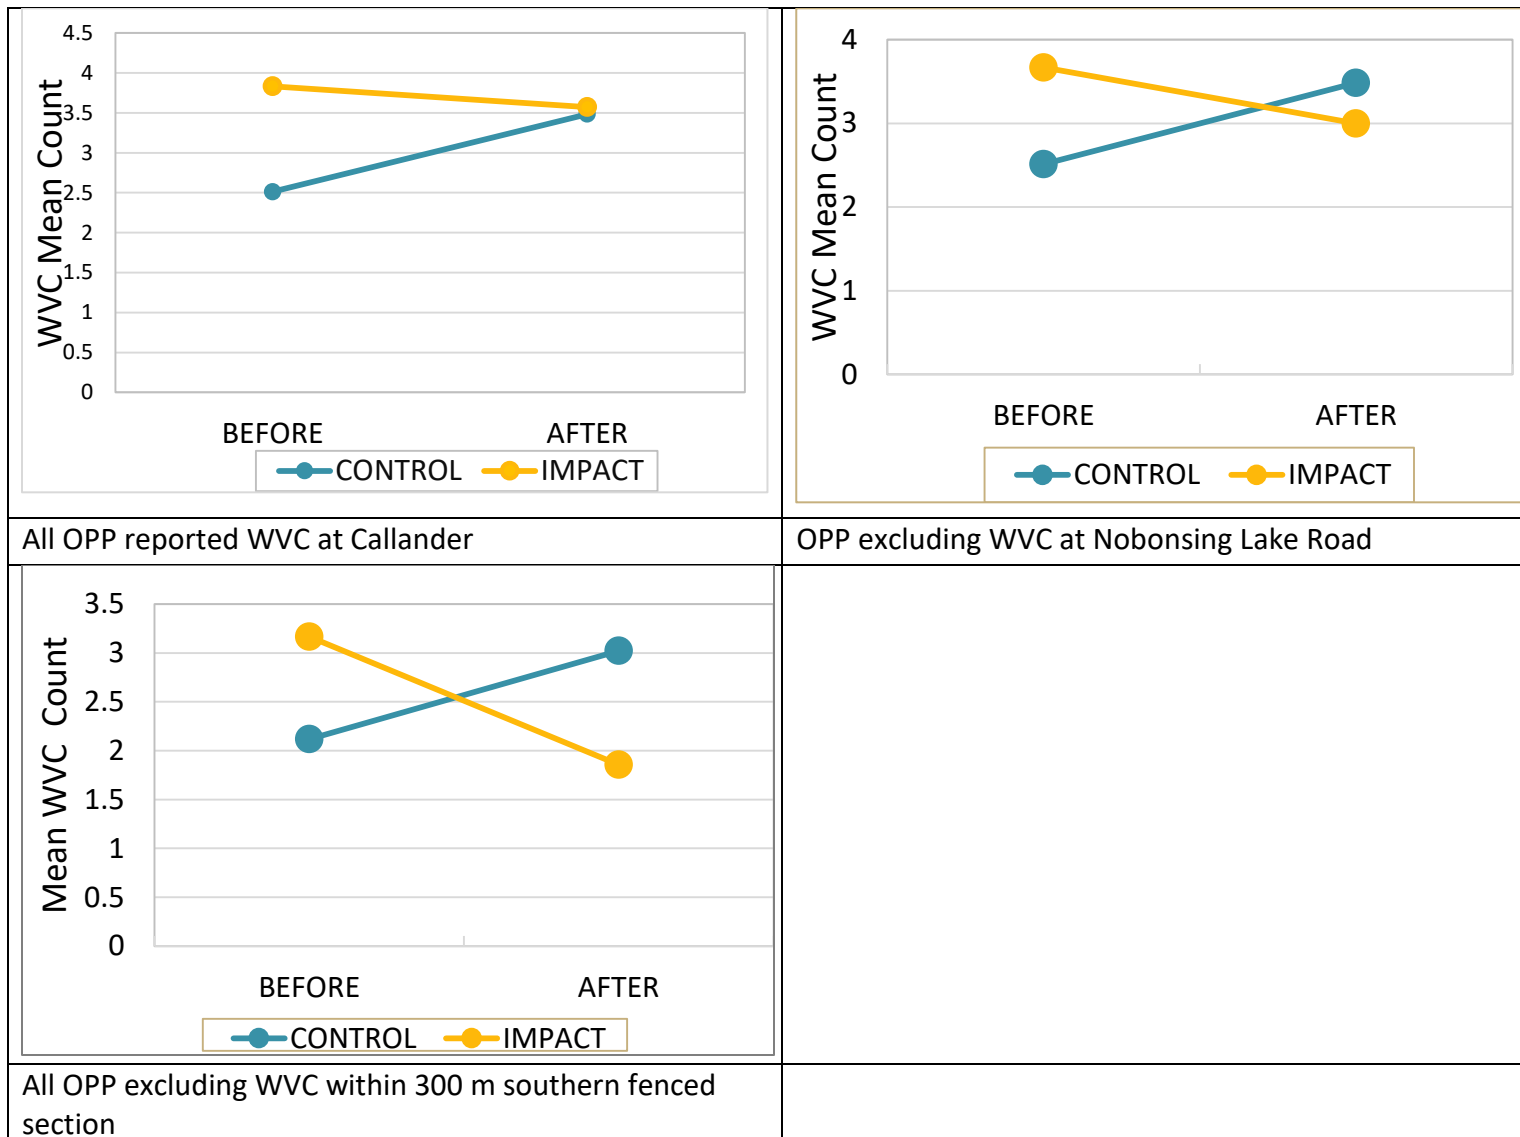
**Figure 6: Before-After-Control-Impact summary charts illustrating mean WVC count before and after installation of wildlife mitigation in the mitigated and control section of highway**

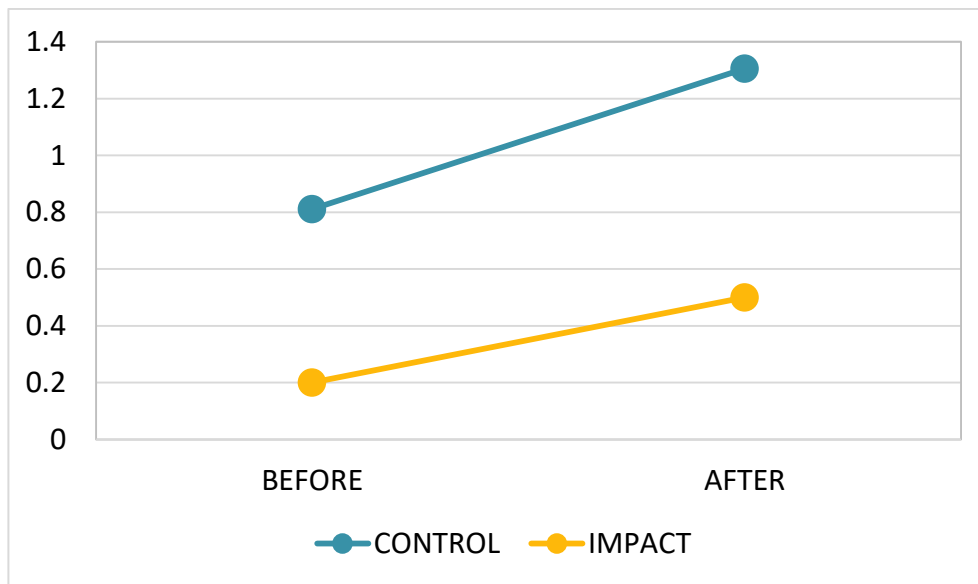
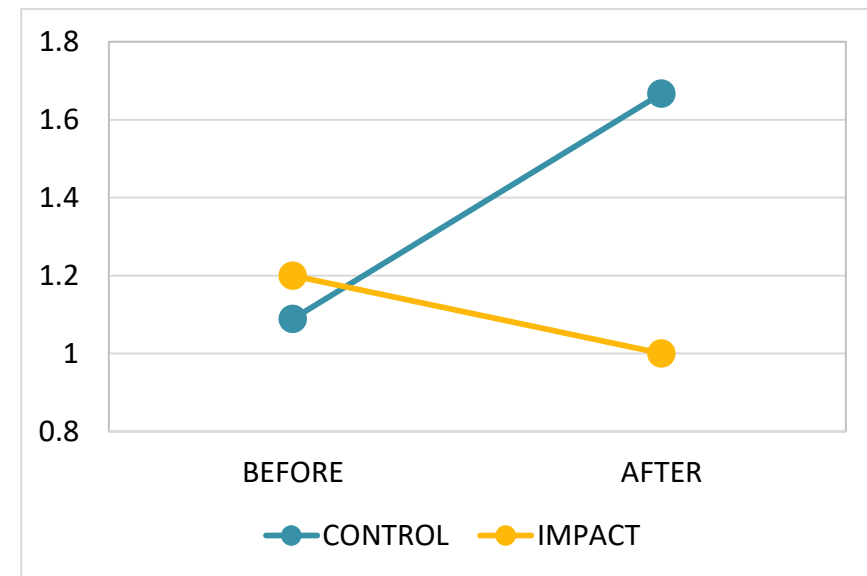
Deer carcasses at Wasi

Large animal carcasses at Wasi

**Figure 8: Mean count of deer carcasses (left) and large animal (right) carcasses, before (2006 to 2012) and after (2014 and 2015) fencing and an underpass was constructed at the Impact and adjacent Control sections of highway.**

There was not a significant reduction in WVC carcasses at the Wasi site ( $p$ -value > 0.05) likely due to only having two years of information after mitigation was installed (Table 5). The BACI chart shows an increase in deer carcasses found in both the Control and Impact highway sections before and after fencing was installed (Figure 8, Left). There is a decrease in WVC large animal carcasses at the Impact highway section with a corresponding increase at the Control sections (Figure 8, Right).

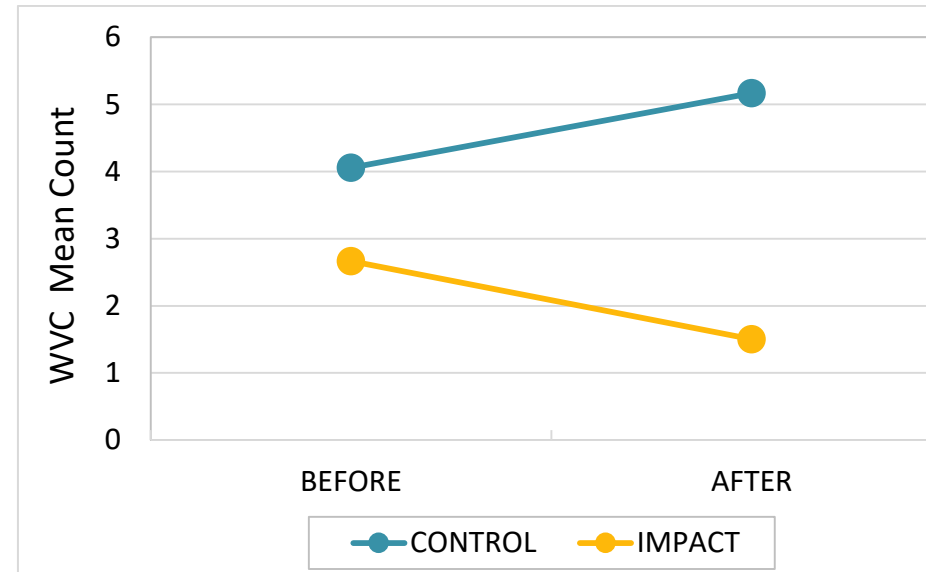
Deer Carcasses at Sundridge

Large Animal Carcasses at Sundridge

**Figure 11: Mean count of deer (left) and large animal (right) carcasses before and after fencing and an underpass was constructed at the Impact and adjacent Control sections of highway.**

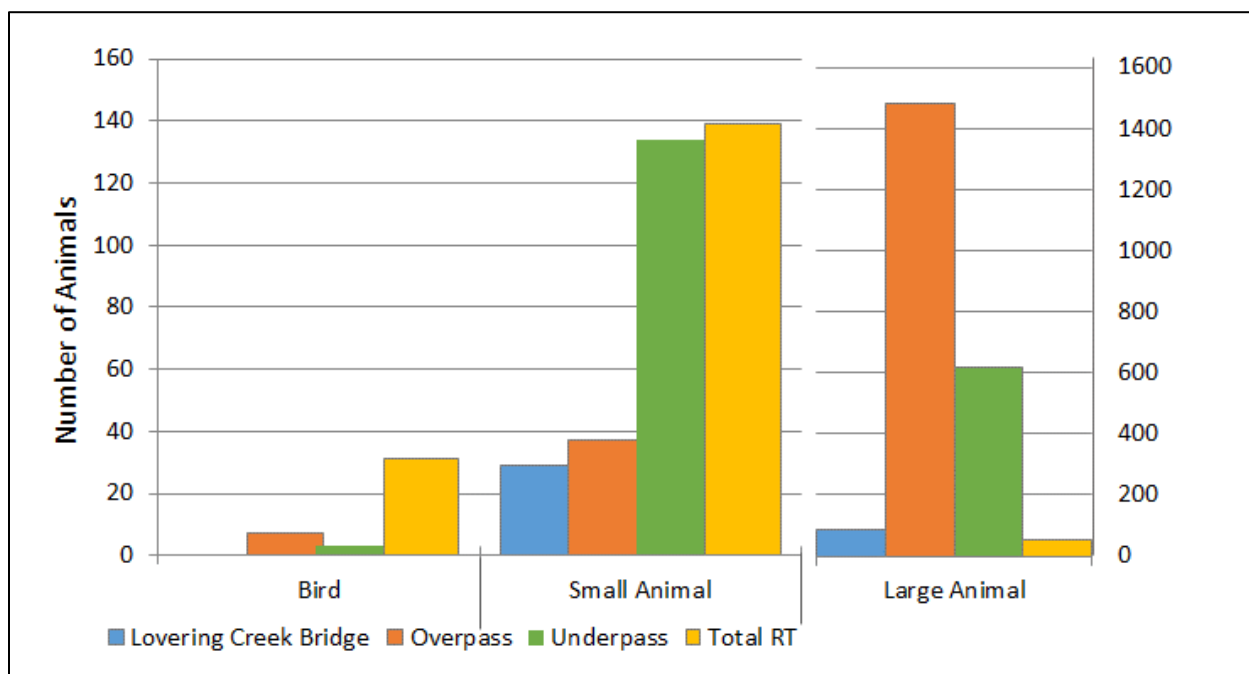
**Figure 16: Number of animals grouped by bird, small animal, and large animal observed from camera monitoring at the crossing structures on Highway 69 and Highway 11**

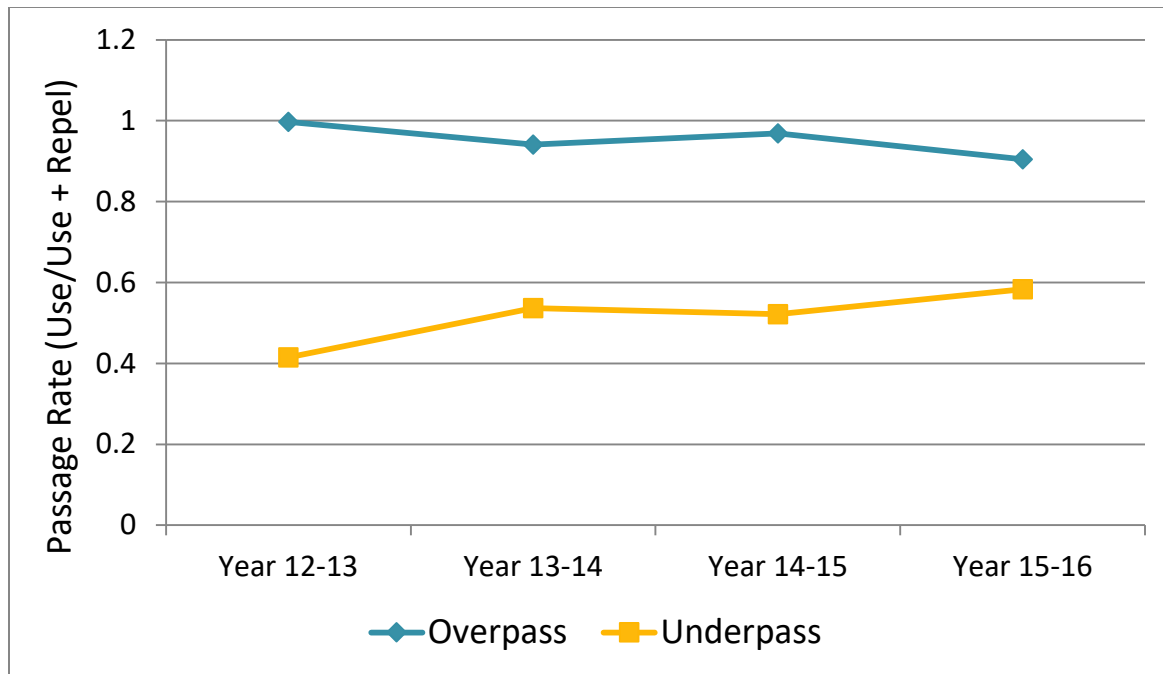
**Figure 17: Passage rates for deer and moose over four years of post-construction monitoring at the overpass and large animal underpass on Highway 69. Each year is defined from September 1st to August 31<sup>st</sup>.**

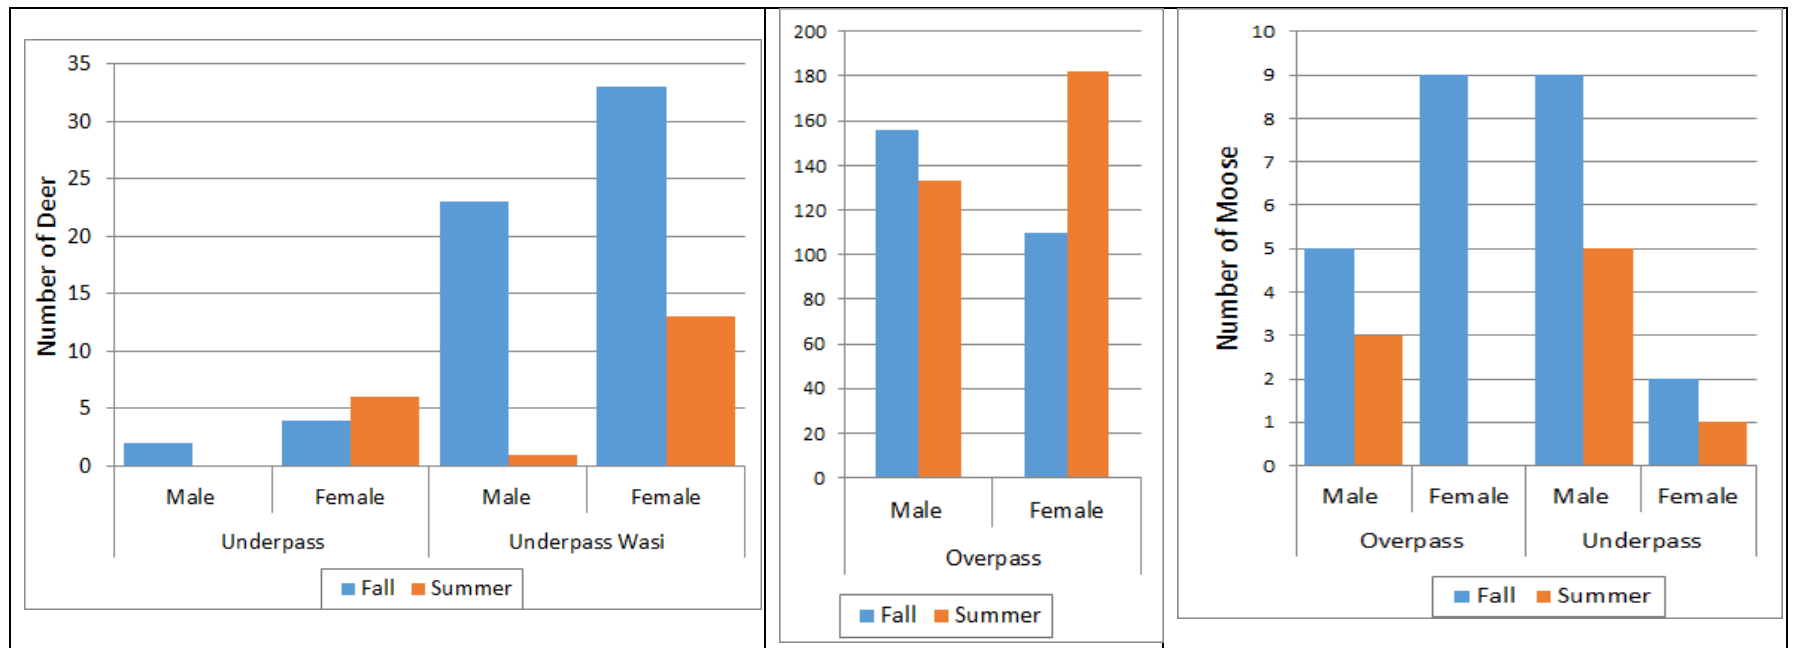
Figure 20: Seasonal use (cross and approach) at the Highway 69 overpass, underpass and Wasi underpass for deer and moose only by sex. Sex determined from photos in fall and winter seasons only.

Both female and male moose used the overpass and underpass on Highway 69 significantly more in the fall season when compared to summer (Figure 20, top right). When all seasons were evaluated, more moose were found on the overpass in the spring than during other seasons (Figure 21) and this was significant in the 2014 monitoring report (Eco-Kare International 2014). There was not a noticeable difference in male and female, or seasonal use at the Highway 69 underpass by deer likely due to low sample size.

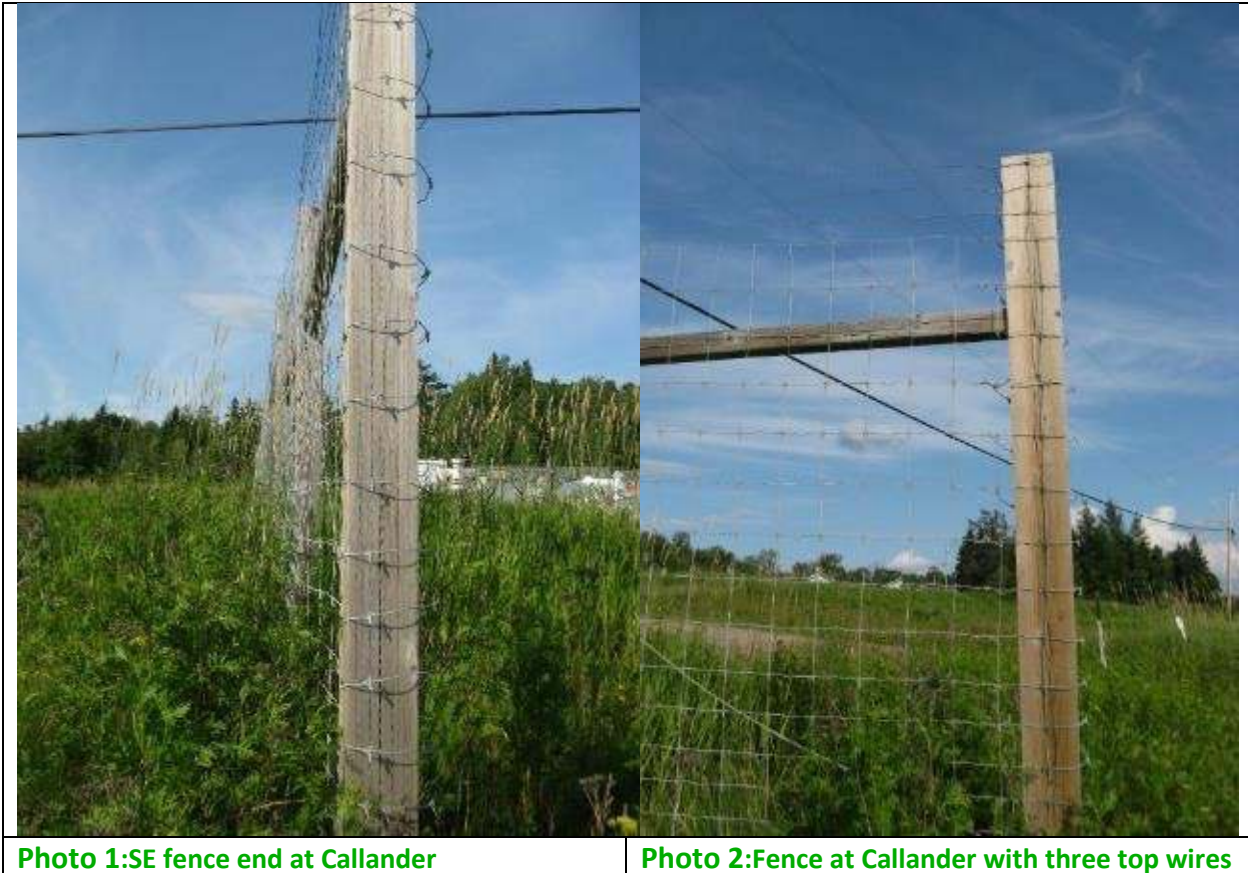
Photo 1:SE fence end at Callander

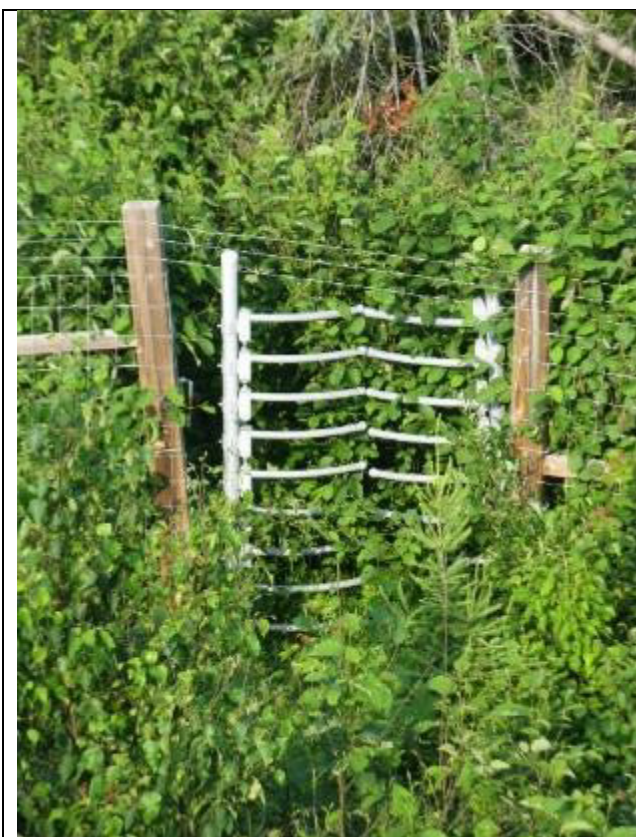
Photo 3: Single one-way gate at Callander (first generation), 17 July 2014

3.5 km of wildlife fencing from highway 654 (Nosbonsing Road) northward + 4 one-way gates (generation 1, Photo 3, 2006) + 8 Jump outs (Photo 7; installed 2006); Fencing repaired and one way gate design modified (generation 2, Photo 4, 2009). Two below-grade road-highway fence gaps, southern fence-ends at-grade, and northern fence ends on-top of rock cliff.	Spacing between prongs increased at animal height in one-way gate generation 2 (Photo 4); Wildlife fencing 2.8 m high that includes three top wires; wood posts (Photo 2).	Retrofit	4 cameras at Jump out, 2 cameras at one-way gates; In Year 2 cameras moved from gates to selected fence-ends; Snow-tracking and WVC crash and carcass data collection.	Trial section selected because intersecting roads were not at-grade and under the highway to funnel animals under Highway 11.
<b>Wasi</b>

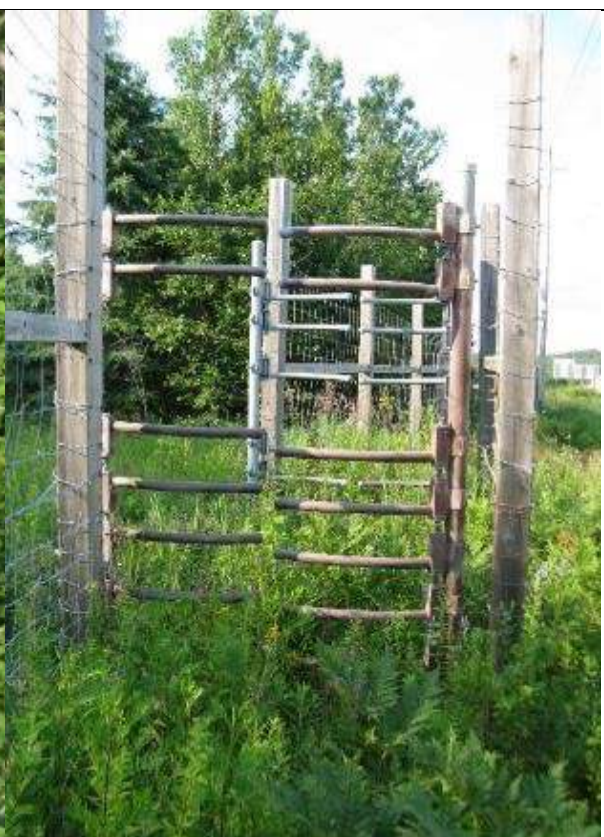
Photo 4: Paired one-way gate at Callander (second generation), 17 July 2014

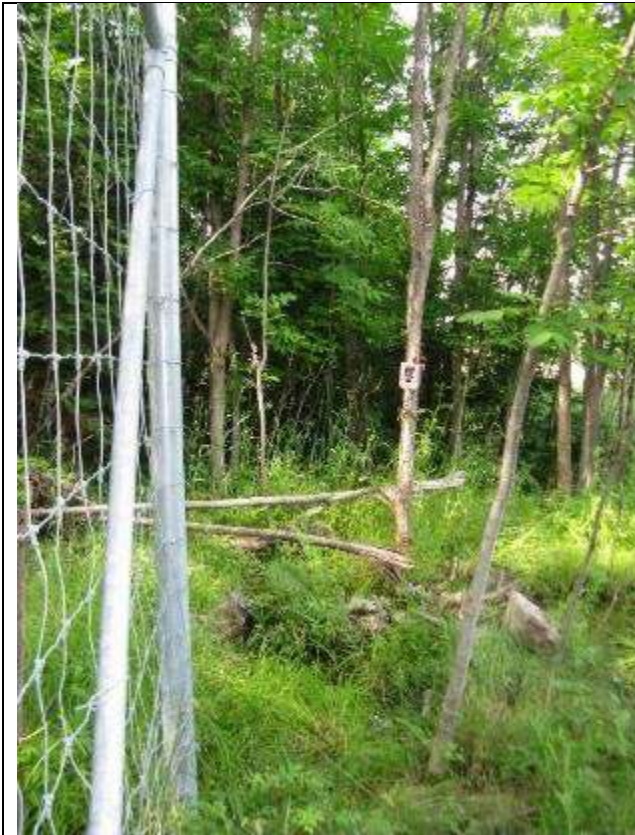
**Photo 20:** Picture of camera on tree pointing at fence end (FENWWAS)

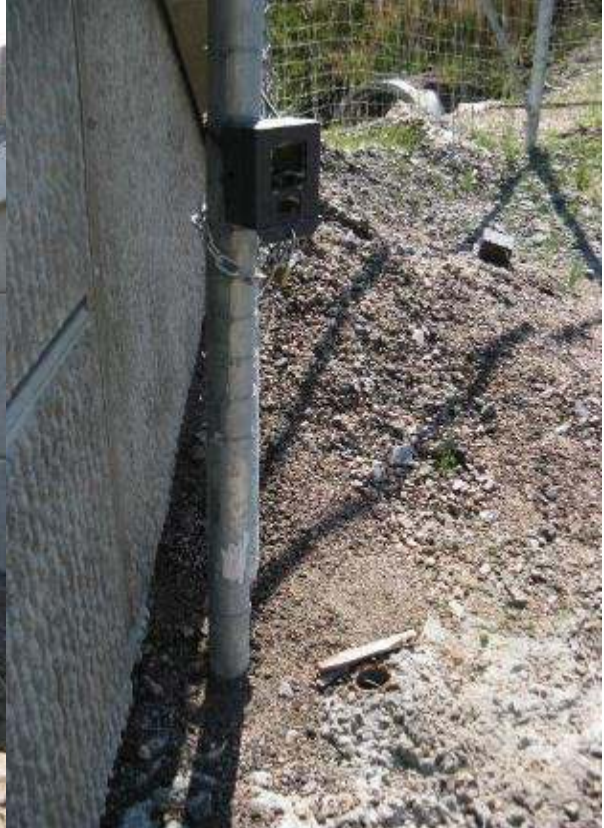
**Photo 27: Camera mounted on the north side in the middle of the Wasi underpass (UPMNWAS)**

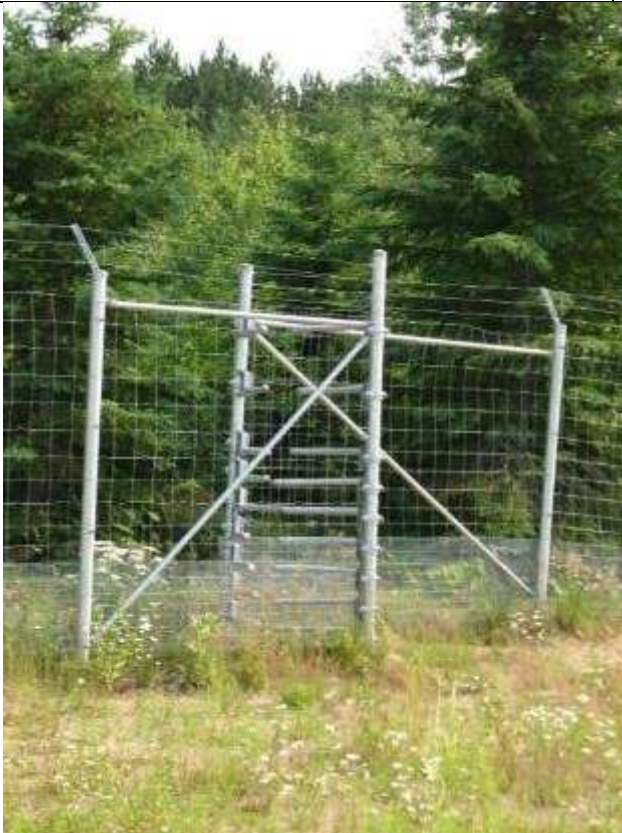
Photo 44: One-way gate with bottom apron

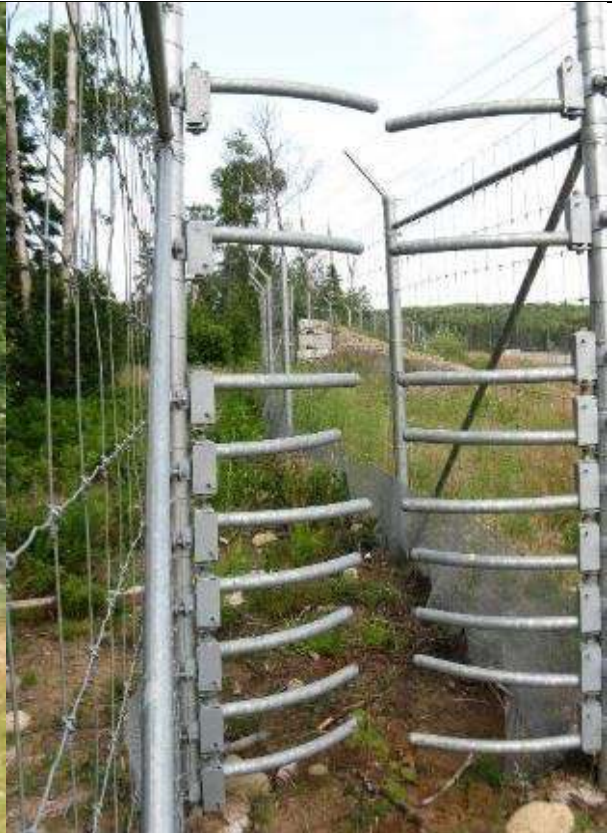
Photo 45: Zoom in of one-way gate at Sundridge with prongs open (OWW18SUN)

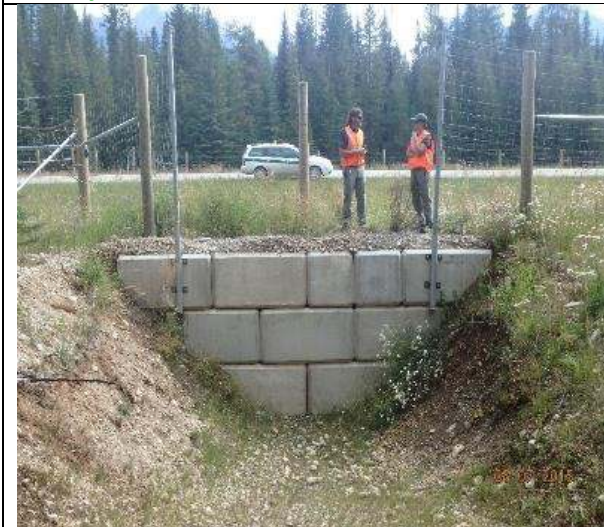
**Photo 58: Jump-out along Highway 93S in Kootenay National Park, 7 Aug 15.**

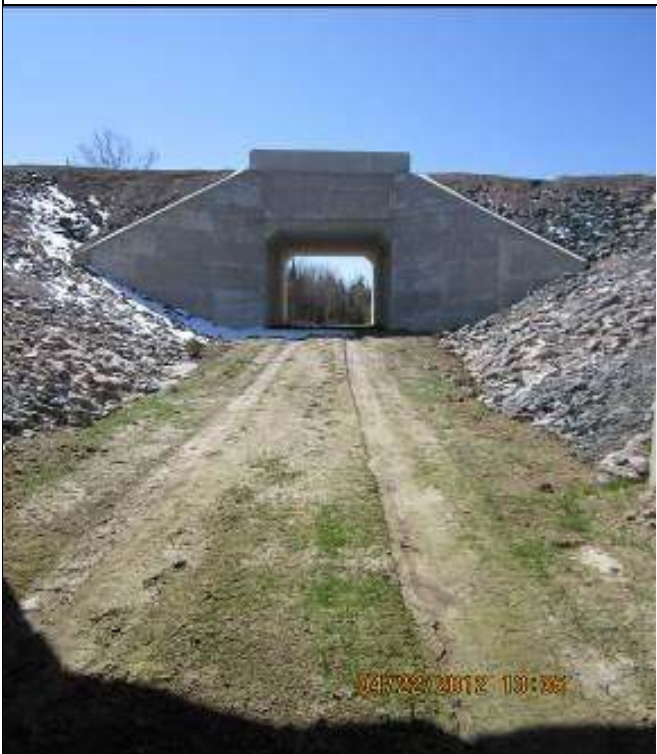
Photo 70: Underpass with access road approach, 22 April 2012

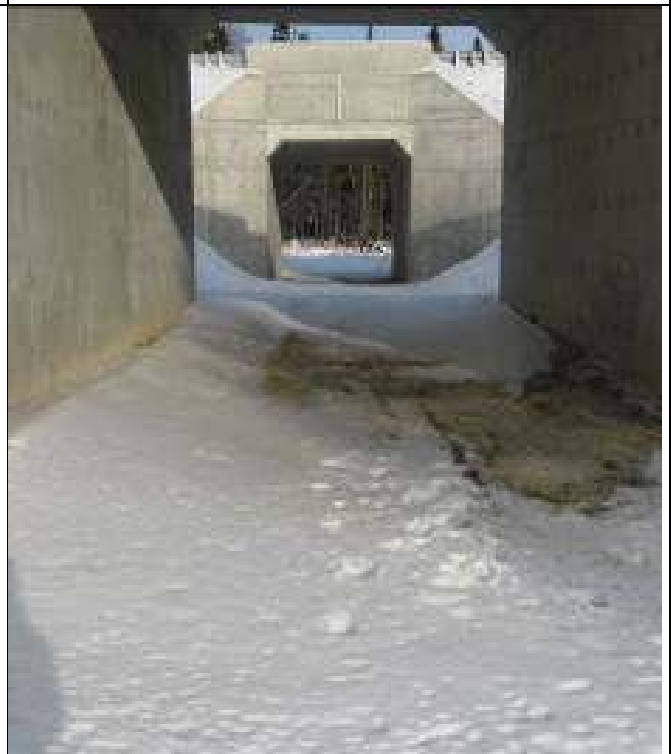
Photo 71: Underpass with open middle in winter

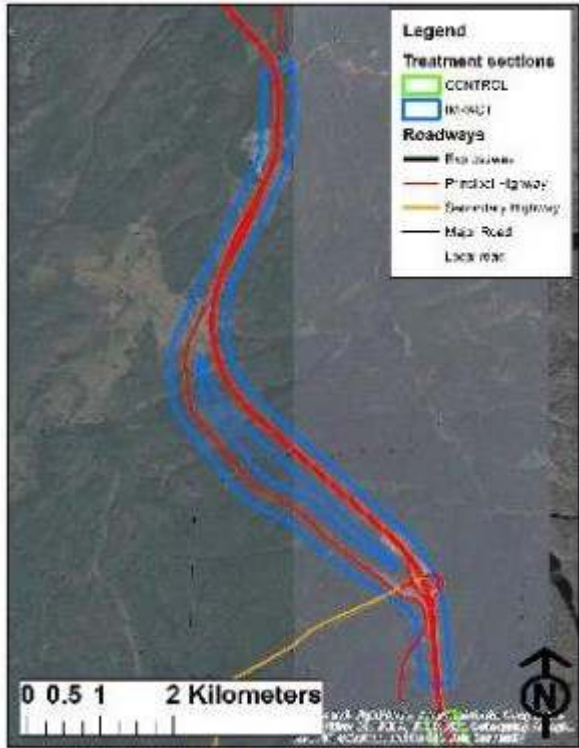
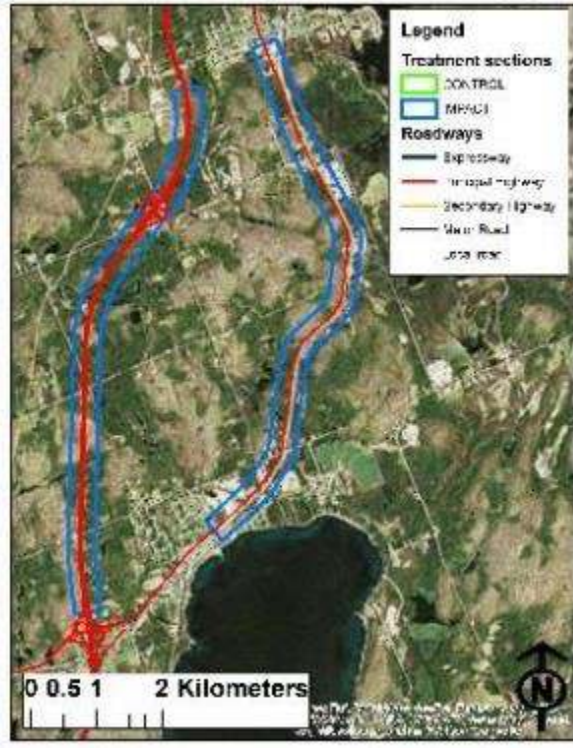
<p>Impact Section Hwy 69: Old Highway 69 and New Alignment</p>	<p>Impact Section Sundridge Hwy 11: Old highway 11 and New Alignment</p>
