1 **A comparison of turtle and snake passage at drainage culverts along two major highways in North**
2 **America**

3 Kari E. Gunson

4 Kari E. Gunson is a road ecologist at Eco-Kare International (kegunson@eco-kare.com)

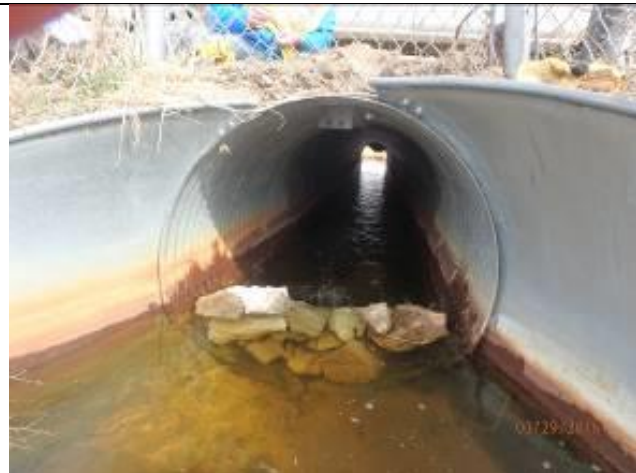
Figure 2a

158 **Figure 2.** Examples of the monitored culverts and exclusion fencing at the study sites: a) Camera set-up
159 on a drainage culvert along Highway 83, Valentine National Wildlife Refuge, Nebraska, USA; b) Snapping
160 turtle moving along chain link fence at Highway 83; c) box culvert with exclusion fencing and rocks to
161 funnel animals under camera on Highway 69, Ontario, Canada. (Photo credits: Kari Gunson).
162

71 At both study sites, one remote-triggered camera (Reconyx PC800 or PC900 model) was installed at the
72 top of one entrance of the selected culverts to monitor wildlife use (figure 2a). At the Valentine Refuge,
73 cameras were set to motion detection only, and at the boreal forest site, cameras were set to both time
74 lapse (10-15 seconds) and motion settings. In addition, rocks were placed at the bottom of the culvert to
75 funnel wildlife under the camera's field of view (figure 2a). When water was present, rocks were placed up
76 to the height of the water and adjusted as water levels fluctuated to optimize the capture of wildlife
77 movements. At the Valentine Wildlife Refuge, cameras were placed at 8 culvert ends and were
78 operational from April 1st to September 30th, 2016. At the boreal forest site, cameras were placed at 18
79 culvert ends and were operational from June to September in 2015, 2016, and 2017.

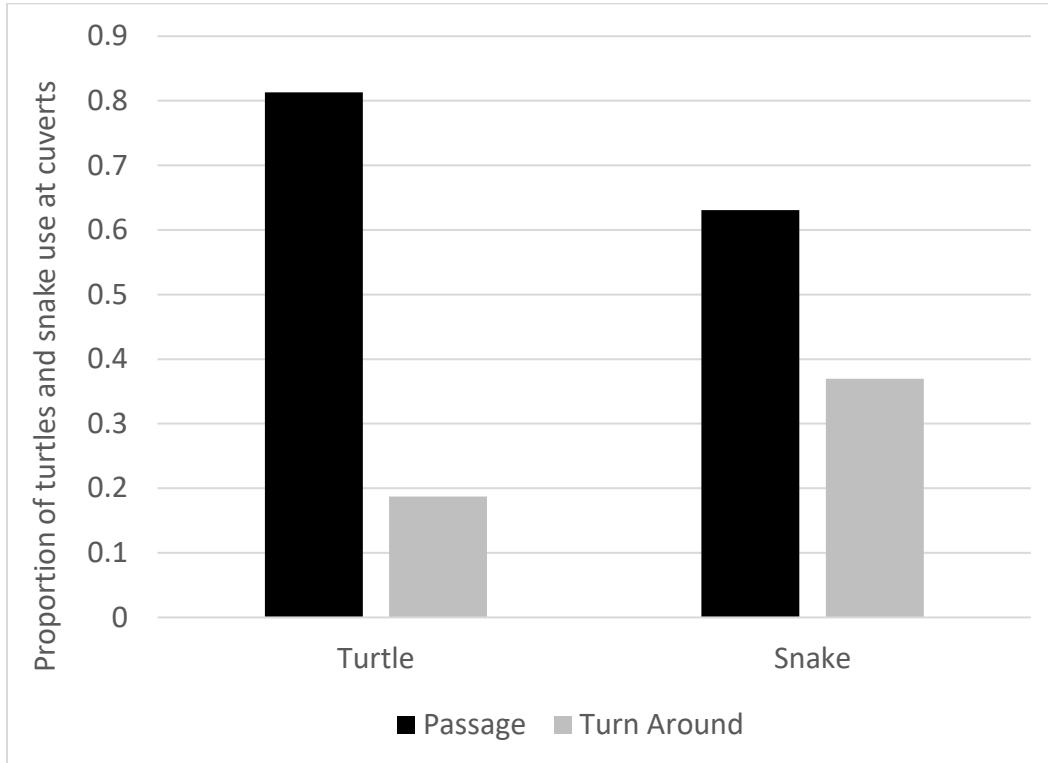
164 **Figure 3:** Percentages of turtle and snake passages and turnarounds at all culverts combined at the two
165 study sites.

103 entered into the drainage culverts in almost equal numbers; however, turtles were more likely to continue
104 through the tunnel 81% of the time as opposed to only 63% of the time for snakes (figure 3). This
105 difference in crossing rates was significant ($\chi^2 = 12.8944$; df = 1, $p = 0.0003$).
