# Ministry of Transportation of Ontario

## Highway Infrastructure Innovation Funding Program 2015 to 2019

### **Specific Topic #14: Beaver Exclusion-Turtle Passage & Reptile Exclusionary Fence Concept Designs: Literature Review and Field Testing**

**14-Jun-2020  
FINAL**

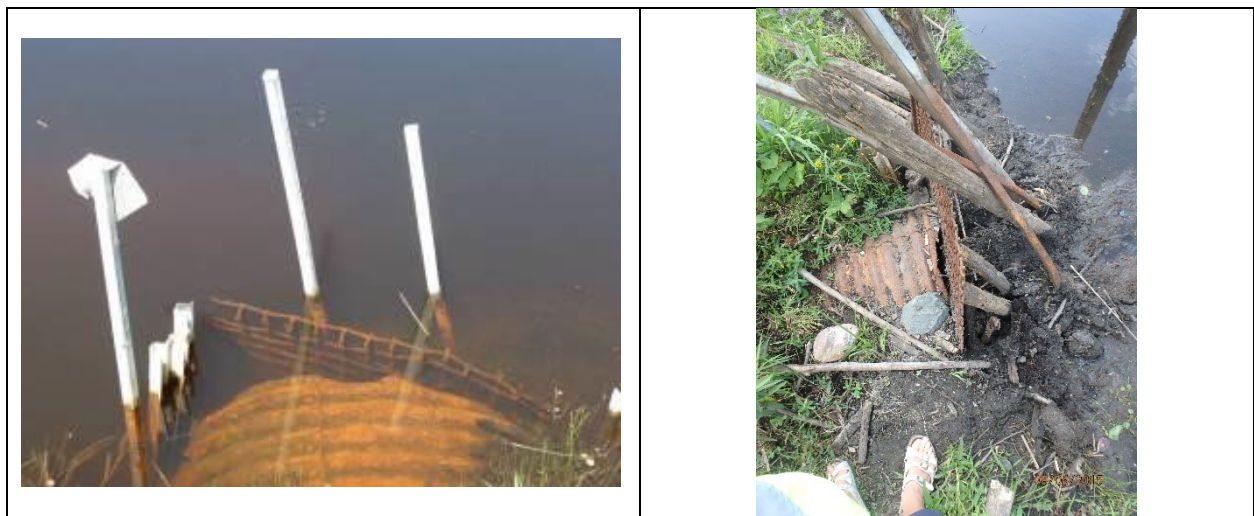
Photo 1: Metal screen placed in front of 800 mm drainage culvert at the study site.

Photo 2: Metal screen (left) plugged with debris and sticks by a beaver preventing water flow

Currently, in Ontario and elsewhere, road maintenance agencies often exclude beavers from the inside of the culvert by placing metal screens on culvert ends (Photo 1). While these screens may be effective at keeping beavers out of culverts, beavers will still block or dam water flow through the screens with sticks and debris, requiring continual clearing and maintenance for the road agency (Photo 2). Furthermore, these screens will obstruct passage for turtles, some snakes and other aquatic wildlife including fish. These screens may also pose a safety hazard causing mortality for turtles that get stuck between the wire mesh holes.

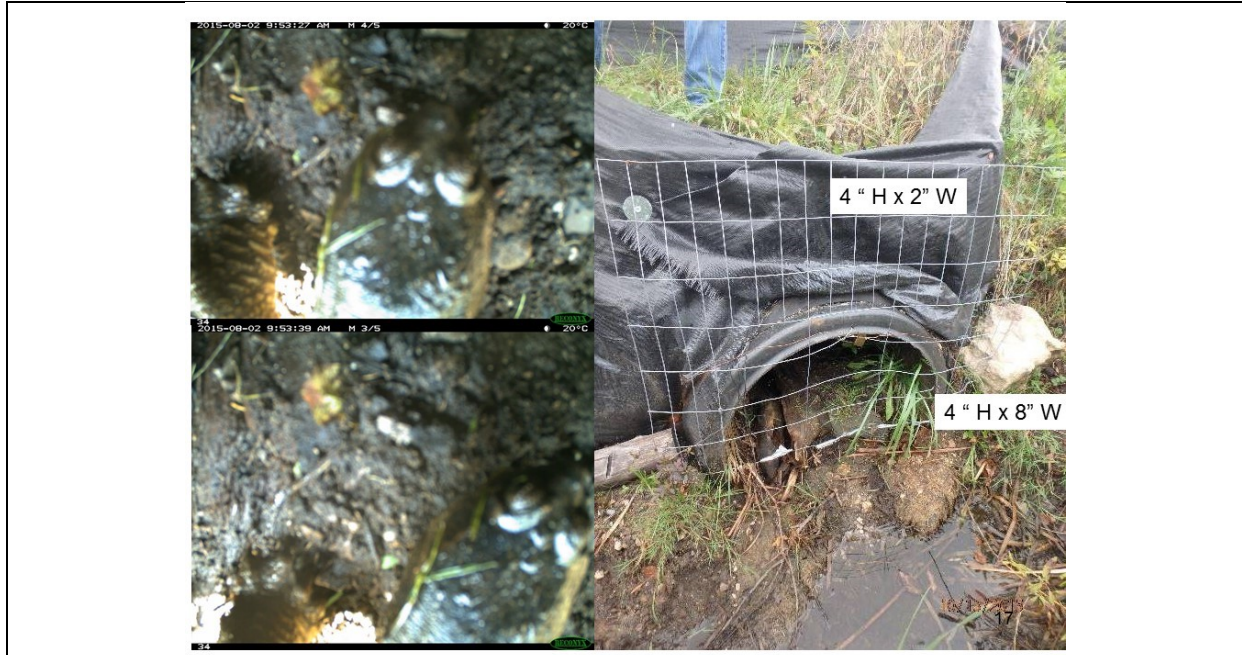
Photo 3. Exclusionary wire screen on the east side of the drainage culvert entrance with larger mesh size at the culvert opening (right) and pictures of Snapping Turtle trying to enter culvert but turning around (left).

On Highway 6, we replaced a beaver exclusion metal screen on the east side of the drainage culvert with a wire screen with a mesh size of 8 inches wide by 4 inches high (Photo 3, right). We then monitored the drainage culvert with a PC800 motion activated Reconyx camera from July 15<sup>th</sup> 2015 to October 13<sup>th</sup>, 2015 to determine what animals would pass through the screen into the drainage culvert. Water levels varied between 10 and 30 cm during the study and no debris blocked the entrance of the culvert with the screen.

culvert. Some mammals were able to enter such as a River Otter (Photo 3) but not larger mammals such as a Raccoon (Photo 6). One mid-sized Snapping Turtle was not able to enter into the culvert (Photo 3, left).

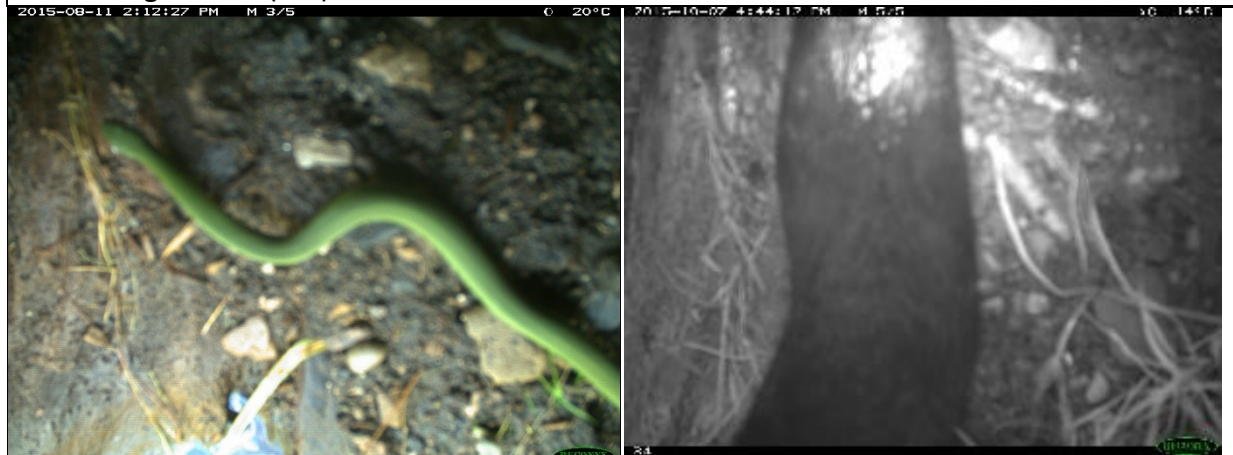
Photo 4. Smooth Greensnake, Aug 11<sup>th</sup>, 2015

Photo 5. Otter tail exiting east side of culvert, Oct 7<sup>th</sup>, 2015

On the east side of the culvert (with screen) snakes (12 Eastern Gartersnakes, 7 Ribbonsnakes, and 1 Eastern Smooth Greensnake, Photo 4) and frogs (Photo 7) were able to enter into the

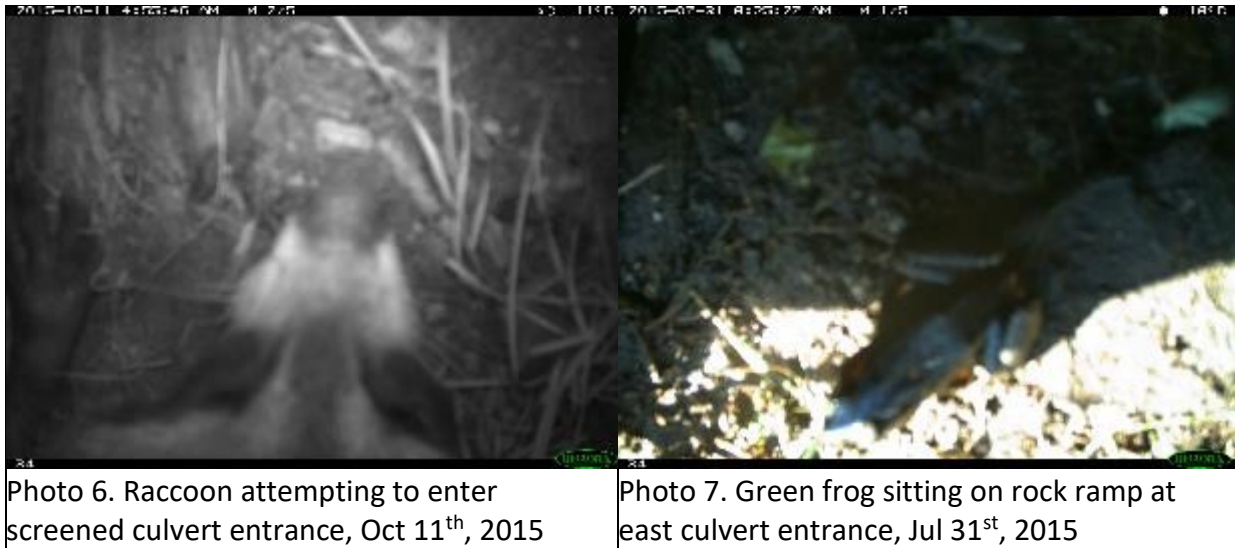
<p>Photo 8. Metal screen with opening at bottom of the southwest drainage culvert for animals to pass under the driveway</p>	<p>Photo 9. River Otter unable to find gap through the screen at the southwest drainage culvert, Sep 20<sup>th</sup>, 2015</p>

On Highway 7, a metal exclusion screen with a ‘hole’ cut in the bottom (8 inches wide x 4 inches high, Photo 8) was placed at the drainage culvert at the southwest fence end along Highway 7 (see Figure 2). The culvert was monitored with a motion activated Reconyx camera (PC800) that was placed at the roof of the culvert at one end from September 6<sup>th</sup> to October 23<sup>rd</sup>, 2015. There was about 1 – 5 cm of water flow through this culvert during the monitoring period. Water flow was impeded by a beaver dam along the highway upstream about 25 meters.

There was a diversity of small mammals that were able to pass through the hole at the bottom of the wire mesh screen. These animals ranged from Muskrat (*Ondatra zibethicus*), Meadow Vole (*Microtus pennsylvanicus*), American Mink (*Neovison vison*), and Deer Mouse (*Peromyscus maniculatus*). The largest animal to pass through was a Raccoon and one River Otter did not find the larger opening and turned around (Photo 9). No turtles were found at the culvert. There were two snakes that passed into the culvert: An Eastern Garter snake and a Northern Watersnake (*Nerodia sipedon*) (Photos 10 & 11).

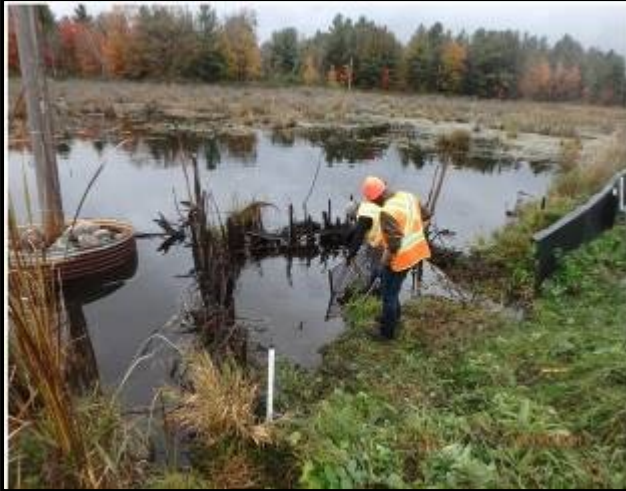
Photo 12: Construction of a diversionary dam around the north culvert entrance on Highway 7

The site was monitored to assess wildlife activity, water levels and flow, and beaver activity at the diversionary dam about one time per month from October 2015 to 2018. After installation, woody debris and mud accumulated at the diversionary dam. The bulk of materials were added to the dam between November 6<sup>th</sup>, 2015 and December 25<sup>th</sup>, 2015 (Photo 14). This suggests that the beaver preferred to dam the diversionary dam rather than the culvert entrance. However, it was noted that the gap for wildlife movement to the culvert was now blocked by debris and mud from the beaver, and water flow through the dam into the culvert was not occurring (see below).

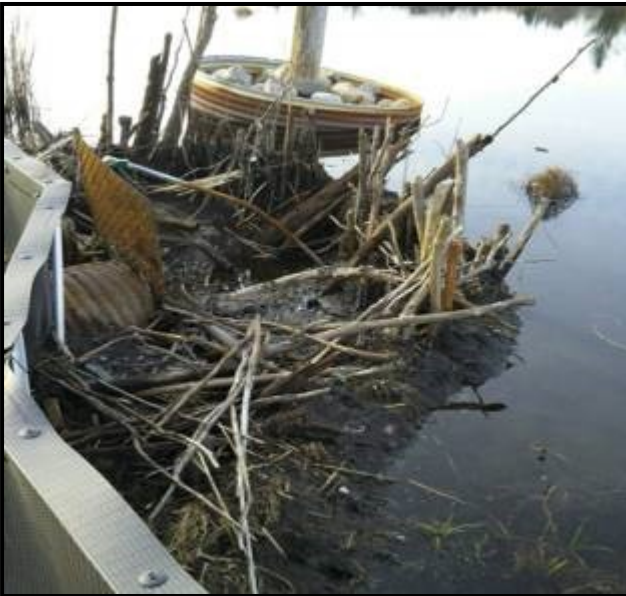
Photo 14: Side-view of dam set-up where beavers used sticks and mud to close the gap between exclusionary fence and the diversionary dam.

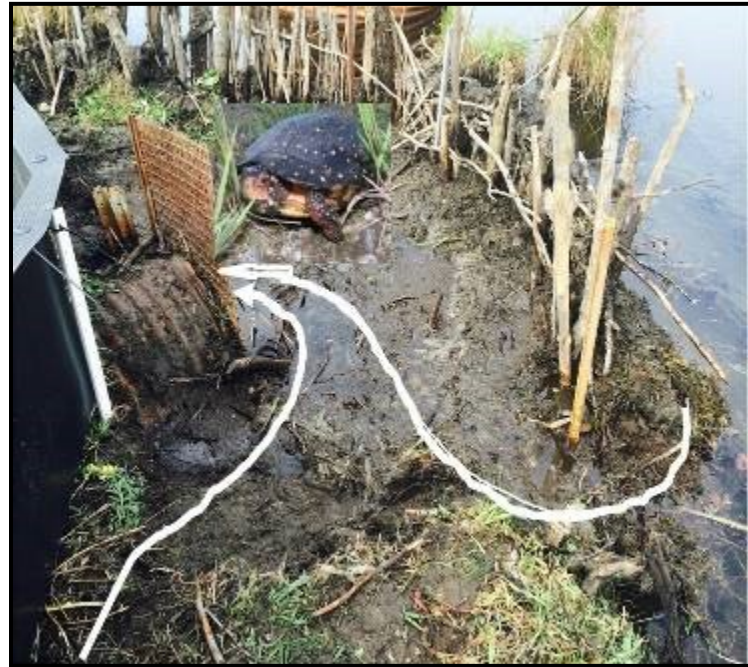
Photo 13: Gap between dam and exclusion fence where a turtle (pasted into photo) could access the culvert, later beavers closed this gap with sticks and mud (Photo 14).

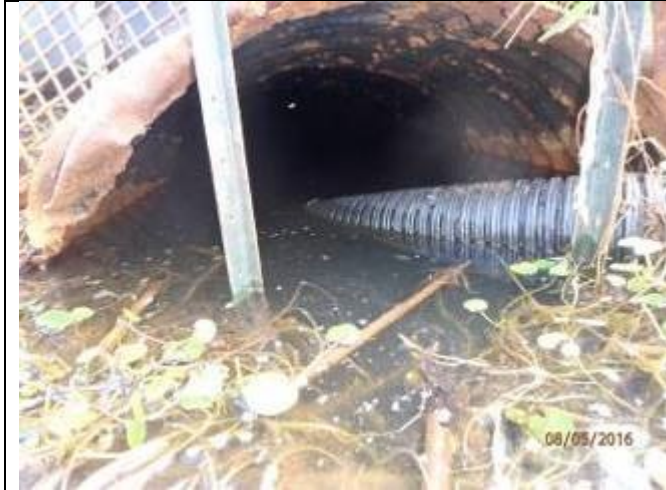
Photo 15: Culvert with two metal t-posts in front of inlet, with pipe anchored on to one (right) post for stability.

The end of the PVC pipe was anchored to the metal cage using plastic ties. The purpose of the cage was to prevent the end of the pipe from being plugged by a beaver or from pond debris. The metal cage was constructed by wrapping a galvanized cattle panel (4 feet by 8 feet with a 6 inch mesh opening) into a cylinder and using malleable plastic-covered metal ties to secure ends. A single circular piece of panelling was cut for the top of the cage, with the overhang wires of both the cylindrical and side panelling being bent and tied together with malleable metal wires.

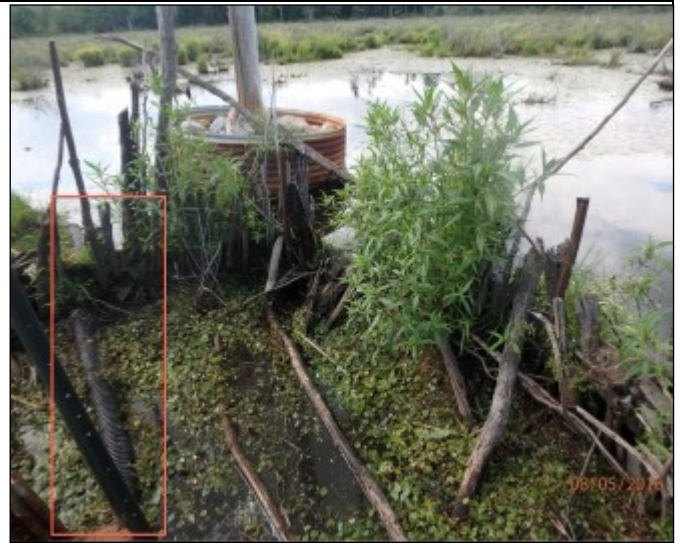
Photo 16: The pipe extended outwards, passing through diversionary dam on west side of culvert, extended westwards, parallel to highway.

A pond-leveler pipe was added through the dam to maintain water flow from the wetland through the culvert (June 3<sup>rd</sup>, 2016). The pond-leveler pipe was a 10-metre long section of 6" diameter black Polyethylene Corrugated Pipe (PCP) placed approximately two feet into the culvert inlet and secured with plastic ties to a metal rod that was hammered into the stream bed at the inlet (Photo 15). The pipe then extended through the dam and about 10 m into the wetland into a metal protective cage (Photo 16-18).

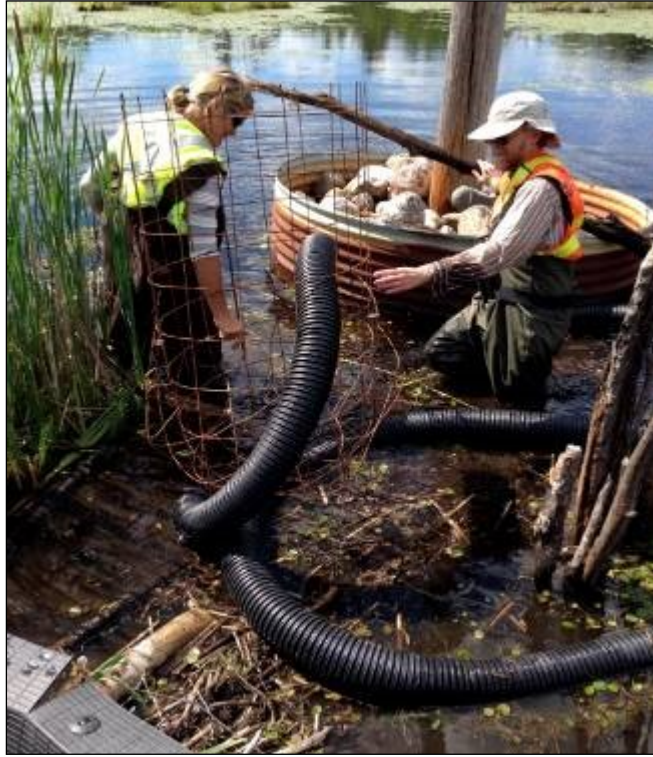
Photo 17: Implementation of cage with pipe into wetland.

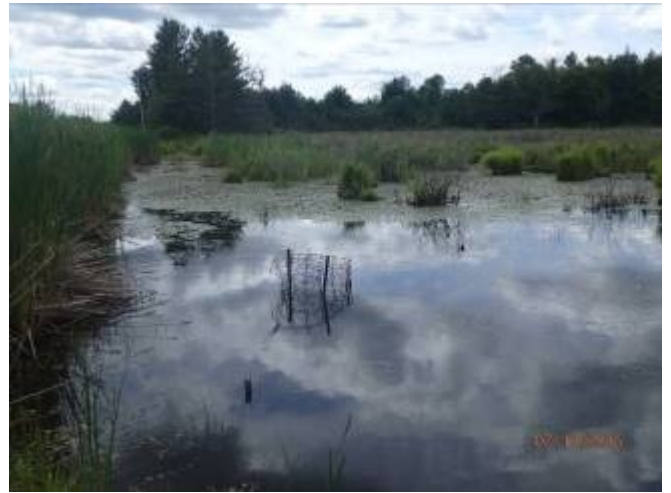
Photo 18: Cage anchored into wetland floor with pipe inserted in a hole at the side.

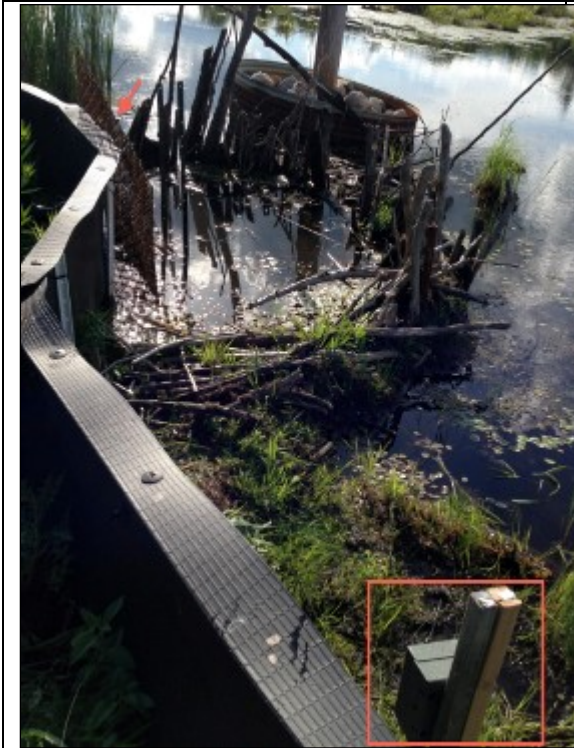
Photo 19: Camera (red box) at east side of culvert facing east side of diversionary dam. Red arrow indicates placement of second camera.

Two Reconyx cameras (PC800) set for motion detection only, were set-up at each side of the culvert facing towards the dam to monitor beaver and turtle activity at the diversionary dam and pond-leveler pipe from June 3<sup>rd</sup> to September 29<sup>th</sup>, 2016 (Photos 18 & 19). At the onset of monitoring, sticks were removed and a rock ramp was built to water level so that turtles following along the exclusion fence could access the culvert.

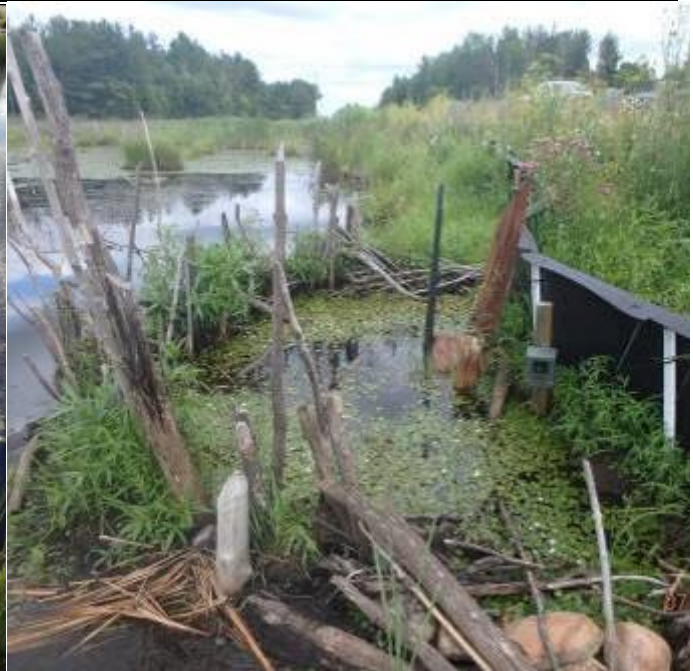
Photo 20: Camera (red box) at west side of culvert facing west side of diversionary dam.

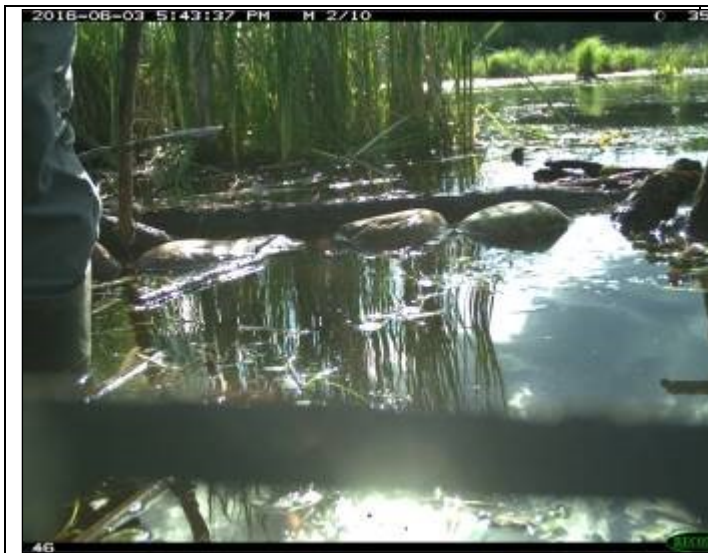
Photo 21: Initial set-up of Reconyx cameras, view of gap between diversionary dam and culvert on west side on 3-Jun-2016.

There was a progressive accumulation of debris and mud at the rock ramp between the dam and exclusionary fence on both sides of the culvert (Photos 21 to 26). It was assumed that the debris (rocks and logs) were moved here by beavers although surprisingly no beavers moving materials were not captured on the cameras. This may be because beavers likely built-up the dam during night hours and the motion detection distance is limited, especially if the beavers work in the water. One Painted Turtle on July 23<sup>rd</sup>, 2016 was observed climbing over the stick debris on the west side and may have entered the enclosure from moving through the drainage culvert.

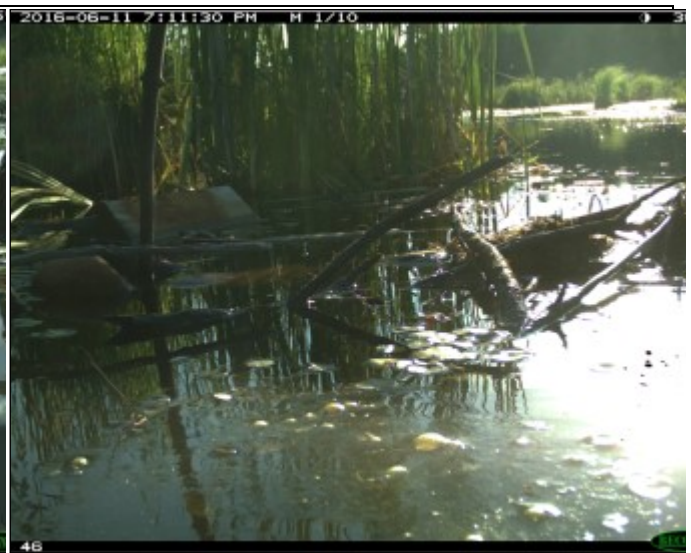
Photo 22: Initial debris accumulation and water level rise on 11-Jun-2016.

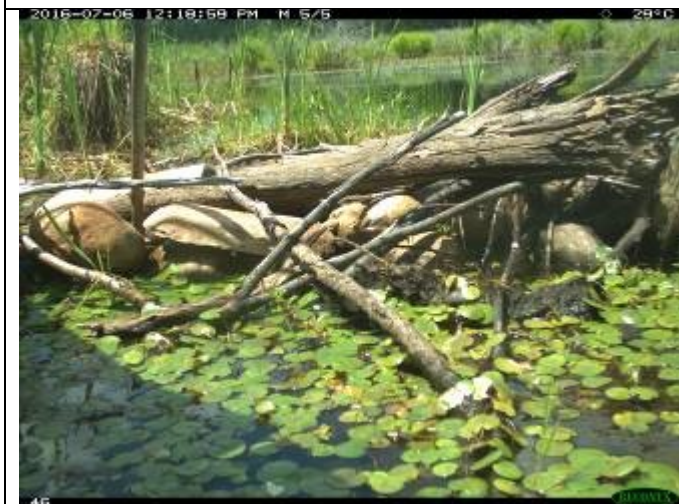
Photo 23: Debris build-up on 06-Jul-16.

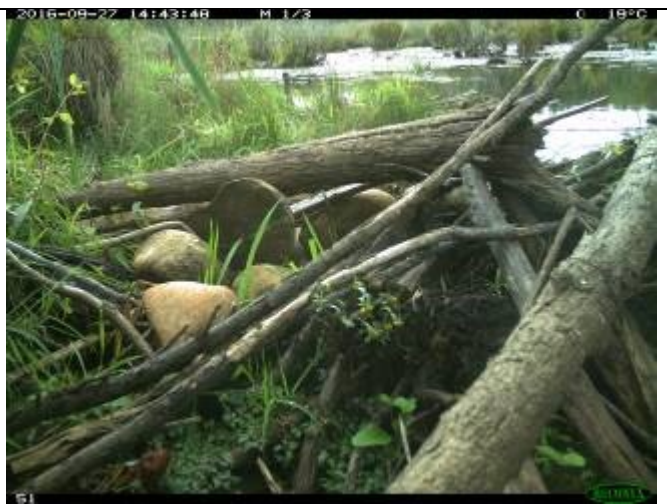
Photo 24: Additional log at far right side on 27-Sep-16.

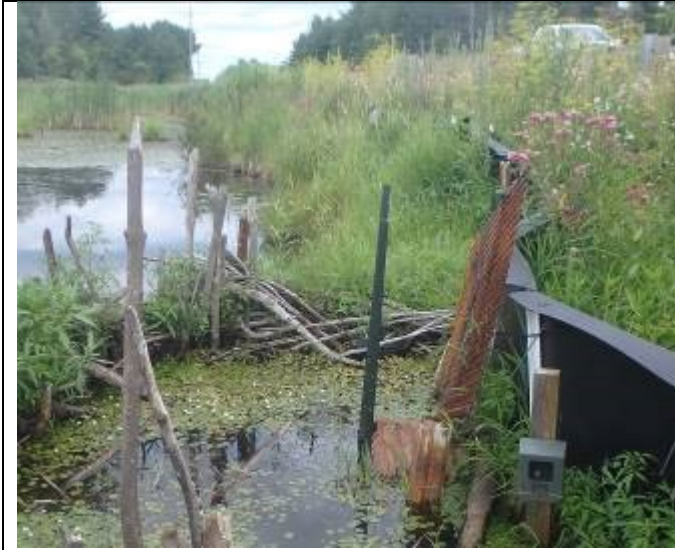
Photo 25: Stick debris on east side of diversionary dam on 10-Jul-16.

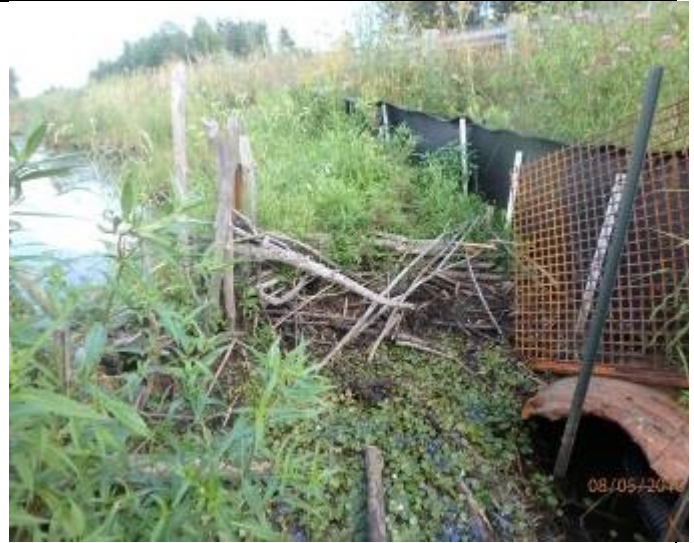
Photo 26: Stick debris on east side of diversionary dam with additional sticks on 05-Aug-16.

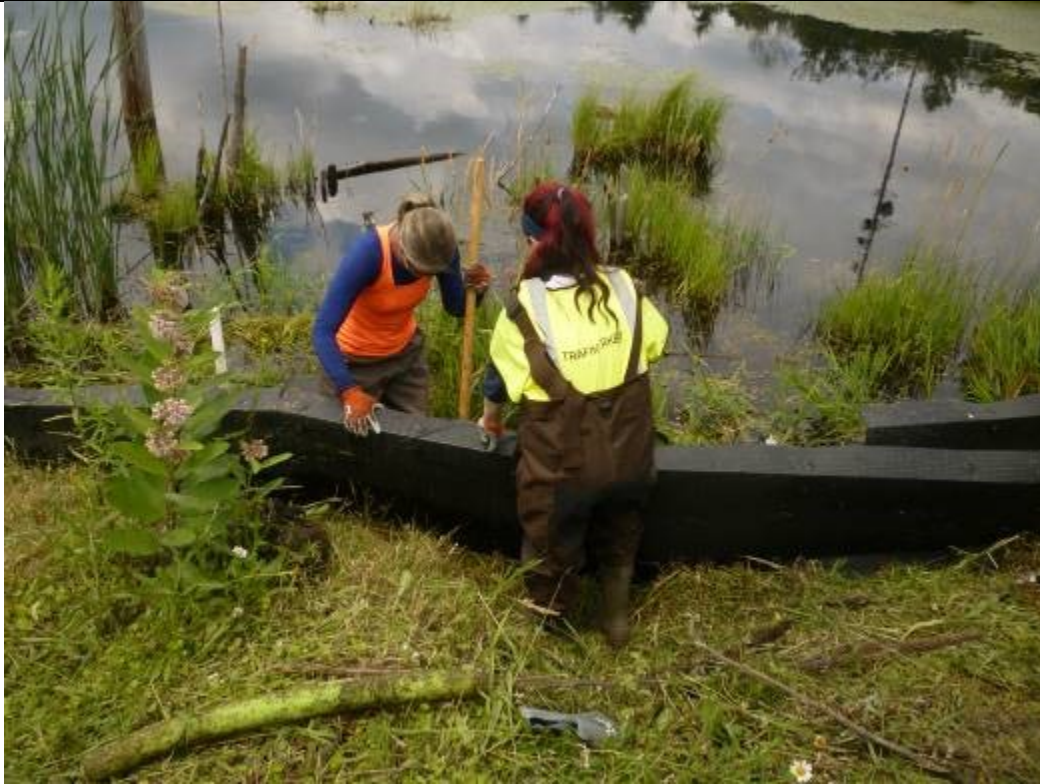
Photo 27: Moving the exclusionary fence to higher ground on the north side of the main drainage on 10-July-2017.

We continued monitoring and adapting the system in 2017. In the spring, water levels were high (100 cm in April and 125 cm in July), almost entirely submerging the diversionary dam, culvert and exclusionary fence. On July 10<sup>th</sup>, 2017, the research team moved the wildlife exclusion fencing back about 1 m to higher ground (Photo 27). On an August 12<sup>th</sup> site visit, the culvert north entrance had been plugged with sticks, presumably by a beaver. The sticks were removed and silt fencing was added as an east and west structure to guide wildlife from the exclusion fence to the culvert (Photo 28). Two metal t-posts were placed at the culvert entrance to deter beavers from entering the culvert.

This improved functionality of the system because the exclusion fence was no longer submerged, and turtles following the exclusion fence would now be directed to the culvert. A gap between the drift fence and diversionary dam was on higher ground and beavers would likely not close this gap because they typically do not carry debris/sticks out of water to dam areas (Mike Callahan, personal communication).

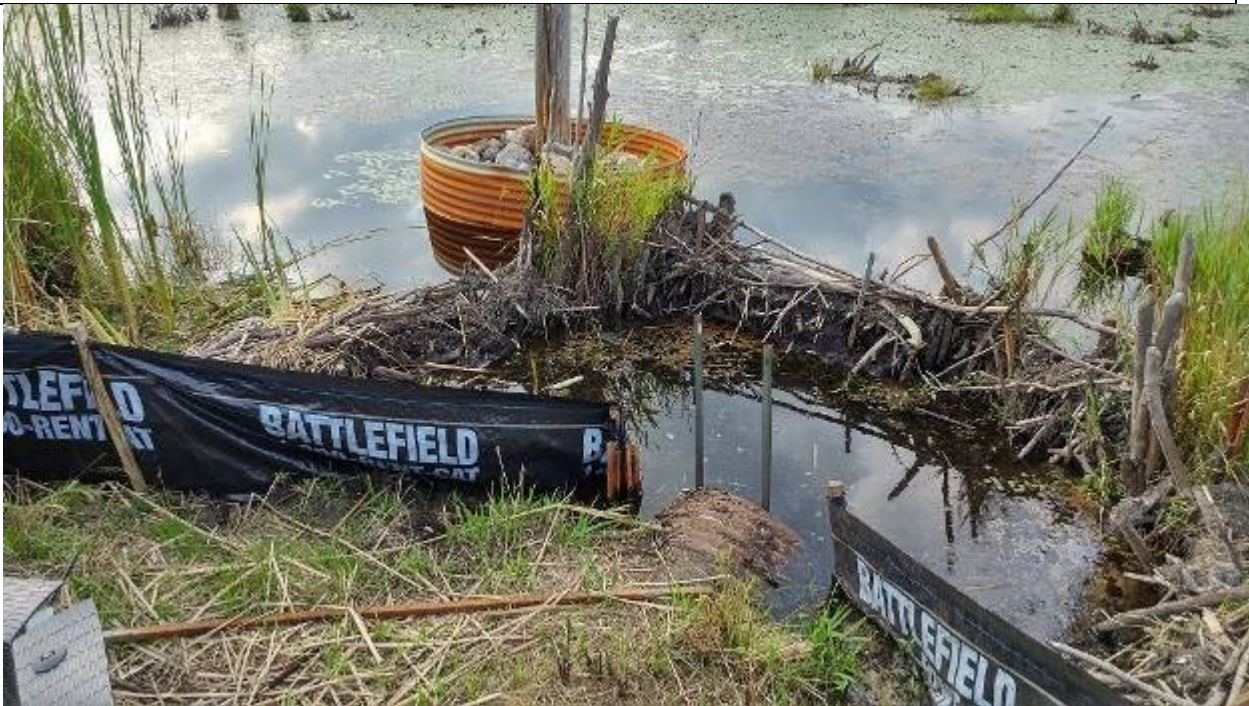
Photo 28: Silt fencing used to guide turtles to culvert on 12-Aug-2017.

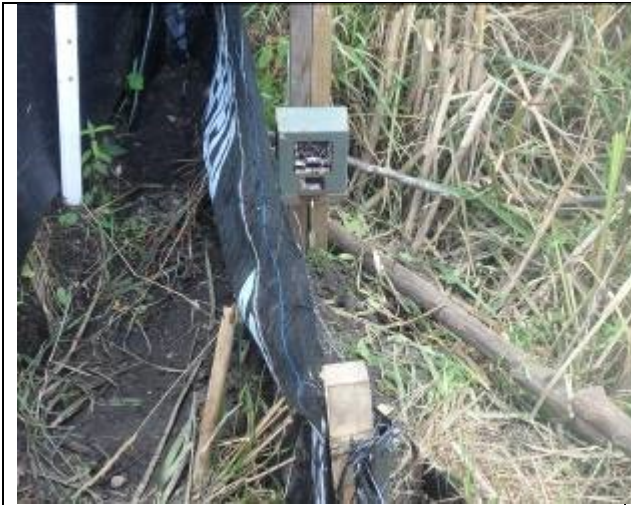
Photo 29: Monitoring camera set-up on west side of culvert on 12-Aug-2017.

Two motion activated Reconyx cameras (PC800) were set-up at the east and west side of the culvert (Photos 29 & 30). By the end of August, it appeared that a beaver had breached the dam in the middle at a low point (Photos 31 & 32) and the gap was closed with logs. The beaver breached the dam again and was captured on camera on two occasions attempting to climb over the exclusionary guide walls. In doing so, the beaver did not plug the culvert or build further on the dam. Muskrats, mink, raccoons, moles, mice and chipmunks were also captured moving along the guide-wall but no turtles.

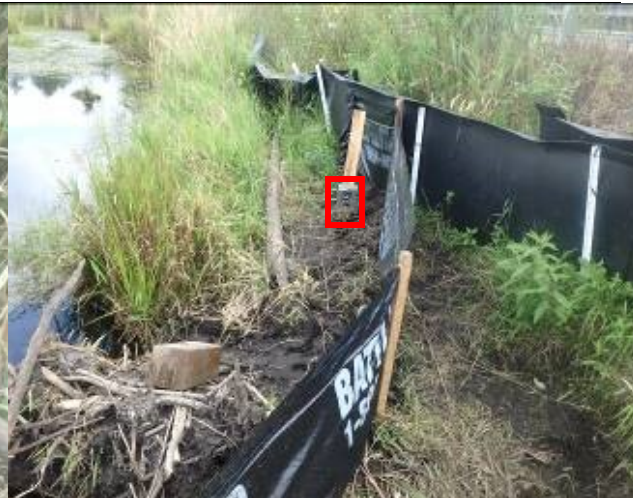
Photo 30: Monitoring camera (red box) set-up on east side of culvert on 12-Aug-2017.

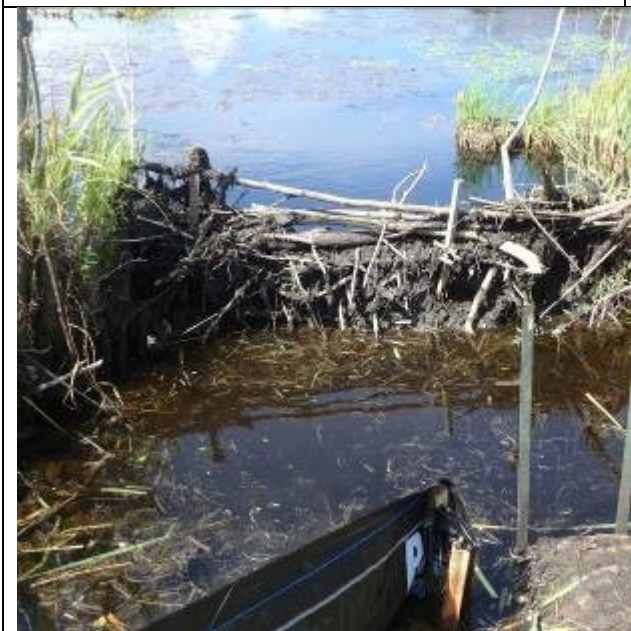
Photo 31: Secured diversionary dam on 12-Aug-2017.

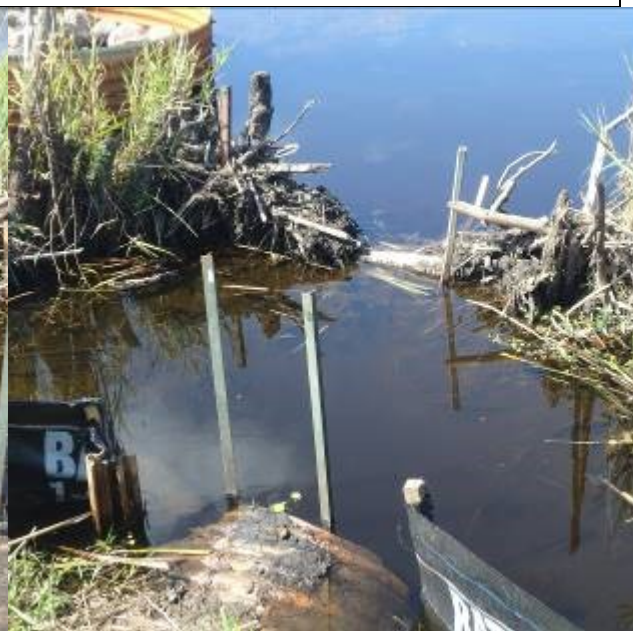
Photo 32: Breached dam presumably by a beaver on 31-Aug-2017.

The diversionary dam was successful in drier years (2015 & 2016), but was breached by a different beaver in 2017 during high water levels. It was assumed that the beaver in 2017 was new to the area because trapping occurs every winter (personal communication, Brad Donaldson, Carillion, Retired maintenance patrol, Madoc Patrol Yard; presently replaced by Richard McCullough, Ercom Services). This beaver was able to swim over the diversionary dam and plug the culvert. Perhaps, if the dam was more exposed the beaver would have worked on the diversionary dam.

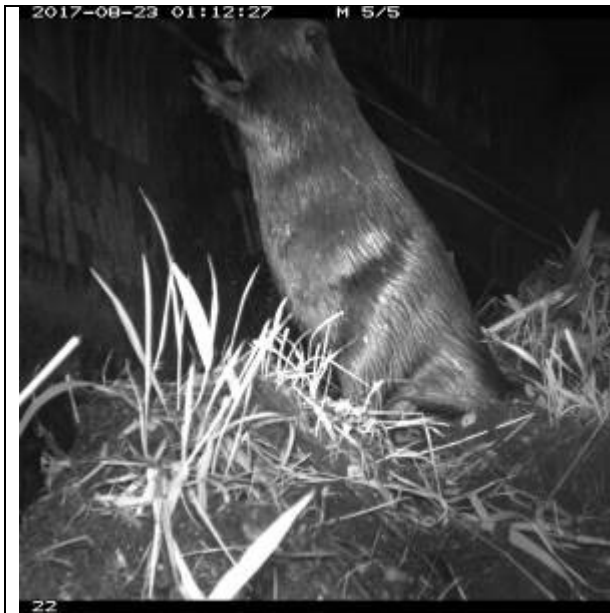
Photo 33: Beaver trying to climb silt fence on wetland (safe-side) side of culvert on 23-Aug-2017.

When water levels receded, likely the same beaver as above, breached the exposed diversionary dam but did not dam the culvert. The photos showed the beaver navigating the exclusionary silt fence (Photo 33). The beaver may not have plugged the drainage culvert because the large dam on the south side of the highway was sufficient to provide the desired water depth.

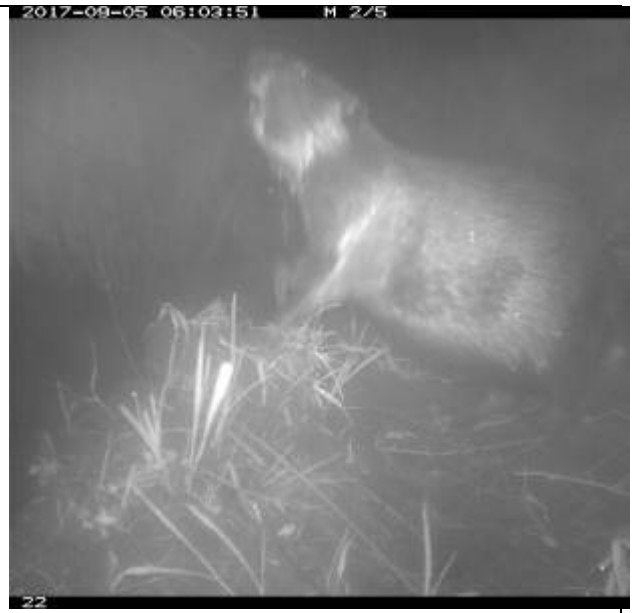
Photo 34: Beaver trying to climb silt fence on 05-Sep-2017.

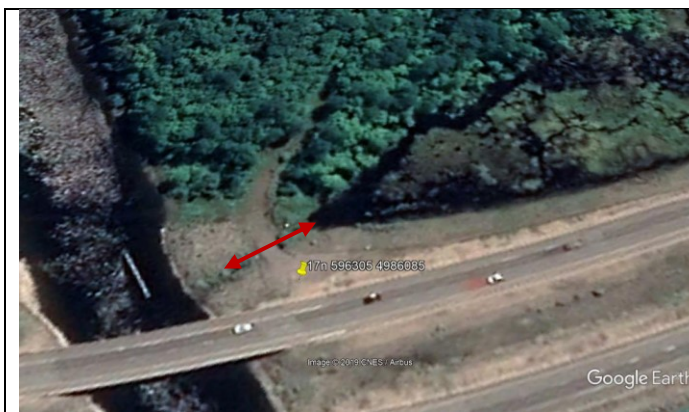
Photo 51: Aerial view of secondary road with culvert providing water flow of stream into river (red arrow), a beaver had dammed the flow at the east end of the red arrow to create a beaver pond (right).

During the literature review it was found that pond-leveler devices or ‘beaver deceivers’ have been installed by the MTO NER in Ontario. A field meeting was conducted with Bob Norrie (Maintenance Coordinator, MTO NER, Huntsville Area) on May 5<sup>th</sup>, 2016 to view an example of a pond-leveler device employed at a secondary road on Highway 69 at the Musquash River (Photos 51-54). Furthermore, an email discussion (July 2019) and teleconference call (July 23<sup>rd</sup>, 2019) was held with retired senior policy analyst, Brenda Carruthers (Team Lead MTO Environmental Policy Office, now retired); Natalie Boyd (new Team Lead in the Environmental Policy Office (absent from teleconference); Jennifer Newman (Senior Policy Analyst, MTO Environmental Policy Office); Kari Gunson Principal, Eco-Kare International); Bob Norrie; and James Hamilton (Maintenance Superintendent, MTO NER, Huntsville Area). The objectives of these consultations were to determine when, how, where and the success of the pond-leveler pipe systems used by the MTO NER.

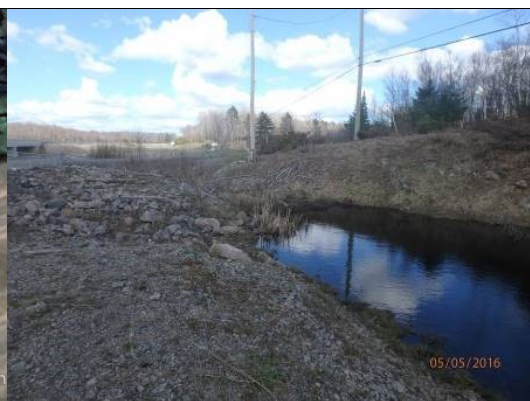
Photo 52: Beaver pond on east side of secondary road.

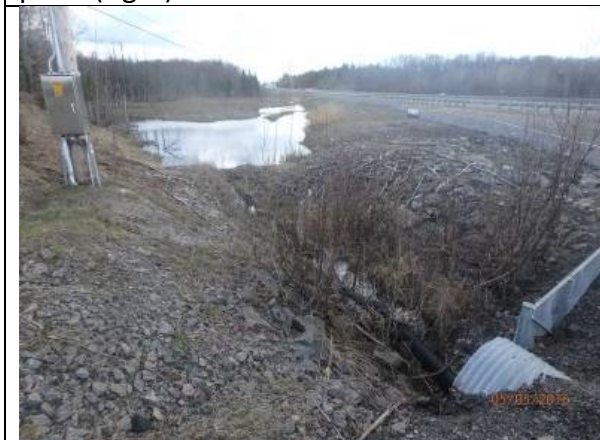
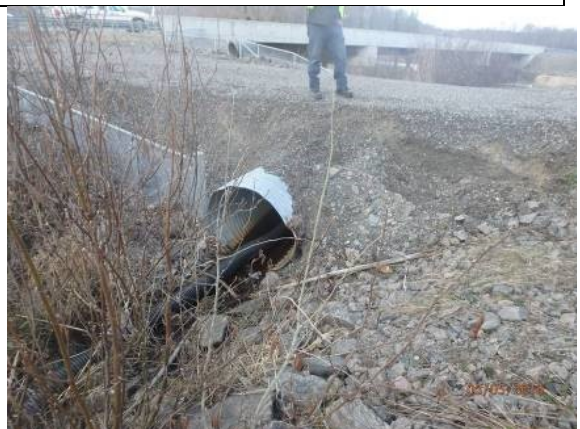
Photo 53: Pond-leveler pipe enters into drainage culvert runs along channel through dam and into wetland and is protected by a cage.	Photo 54: Black pipe extending inside culvert.
--	--

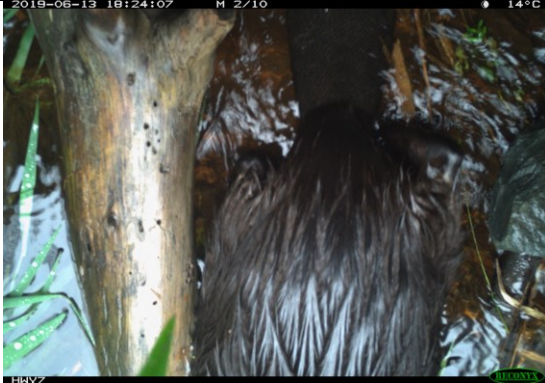
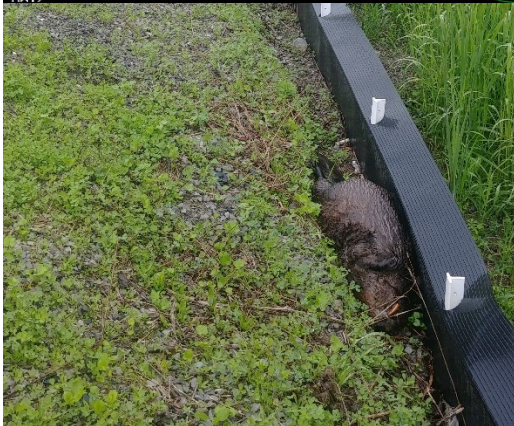
Photo 35: A live beaver (top) going through culvert under driveway near dam; dead intact beaver (bottom) found along south side of exclusion fencing in May 2019.

There were no new jump-outs or escape opportunities installed because about 75% of the fence height was below-grade and about 20-30 cm was above-grade. It is assumed that most small mammals and turtles could scale the 20-30 cm above-grade fencing. However, two dead beavers were found along-side the exclusion fence in 2017 and in 2019 (Photo 35). It is unknown whether these animals were road-killed or died of other causes.

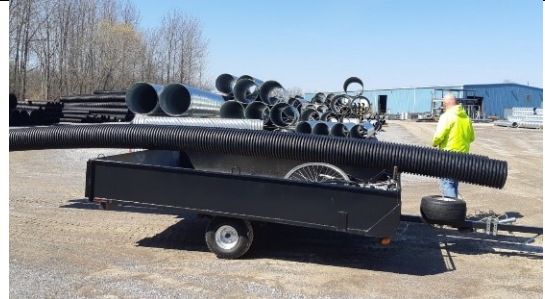
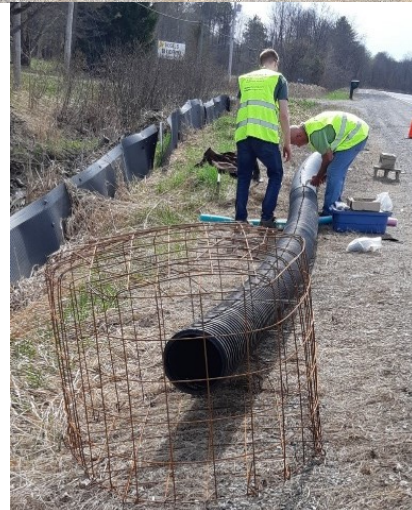
Photo 36: 6-foot 250 mm HDPE Pipe transported and assembled into protective cage on site.

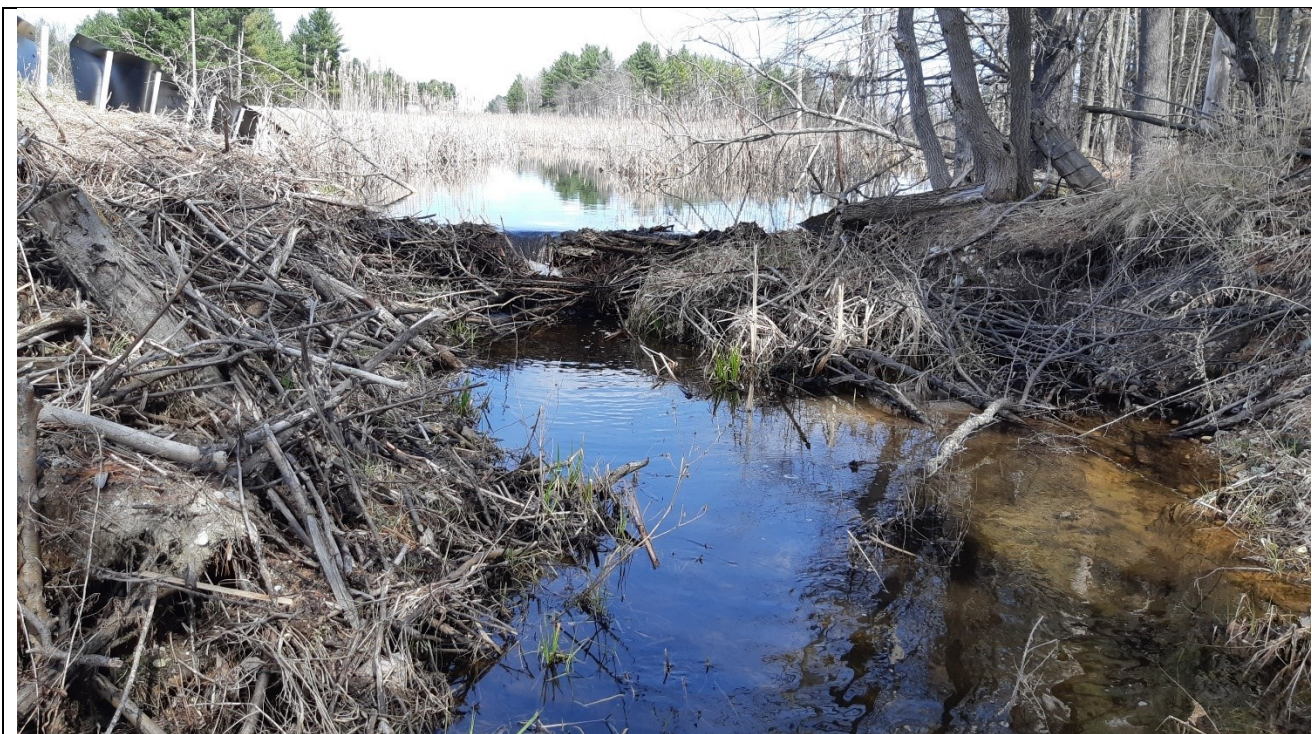
Photo 37: View upstream of the large beaver dam in a channel that flows to the southwest drainage culvert.

On May 3<sup>rd</sup>, 2019, a pond-leveler pipe at the large beaver dam was carefully installed using the design and direction developed by beaver solutions (see video at <https://www.youtube.com/watch?v=LVfpRBzk5PM>, Figure 3, Photos 35-38). Two 6-foot lengths of 12 inch (250 mm) dual-walled BOSS 2000 High Density Polyethylene Pipe were joined with a coupler and installed through the dam. Steel fence sheets sometimes referred to as cattle fencing panels (6 gauge) 4 feet by 8 feet with a 6-inch mesh opening were used to construct a 5-foot diameter cage around the inflow that was placed in about 1.5 metres of water. The outflow pipe was installed at the highest point of the dam and the bottom of the pipe was about 9 inches (22.9 cm) below the upstream water level.

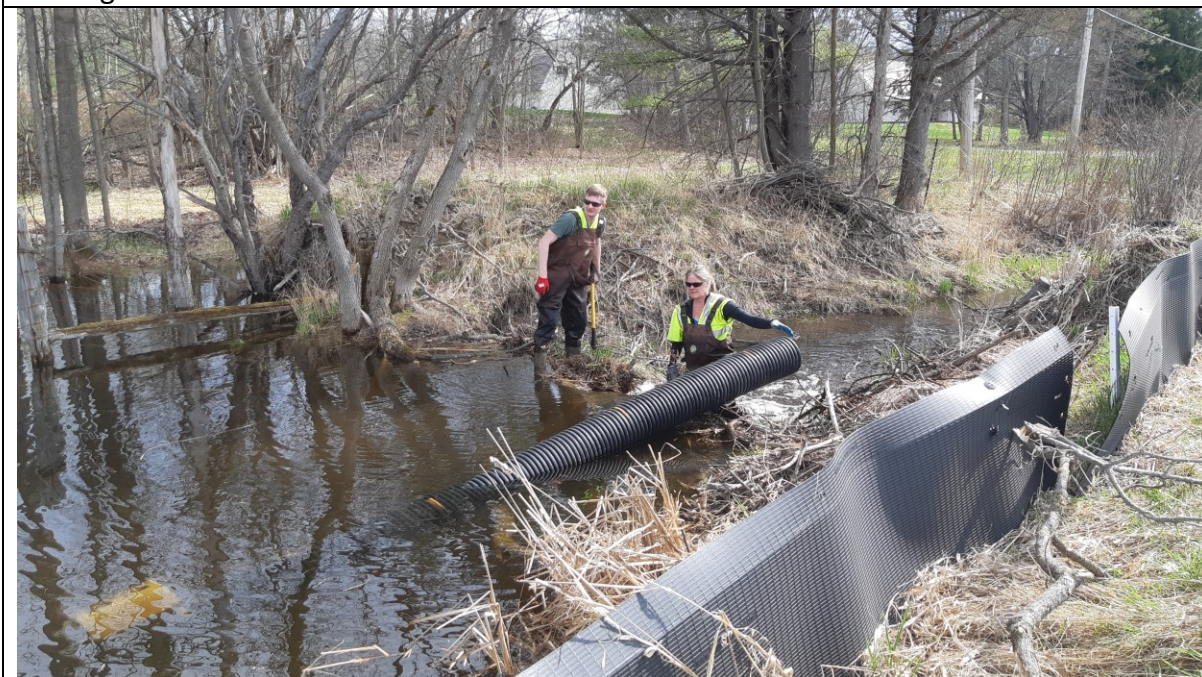
Photo 38: Placing the pipe into the beaver dam.

The pond-leveler system was relatively easy to install after reviewing guidance from the Beaver Institute and obtaining the supplies. Water levels were reduced to the level of the pipe in the dam (about 6 inches). One live Beaver was observed at the site on June 13<sup>th</sup>, 2019 10 m

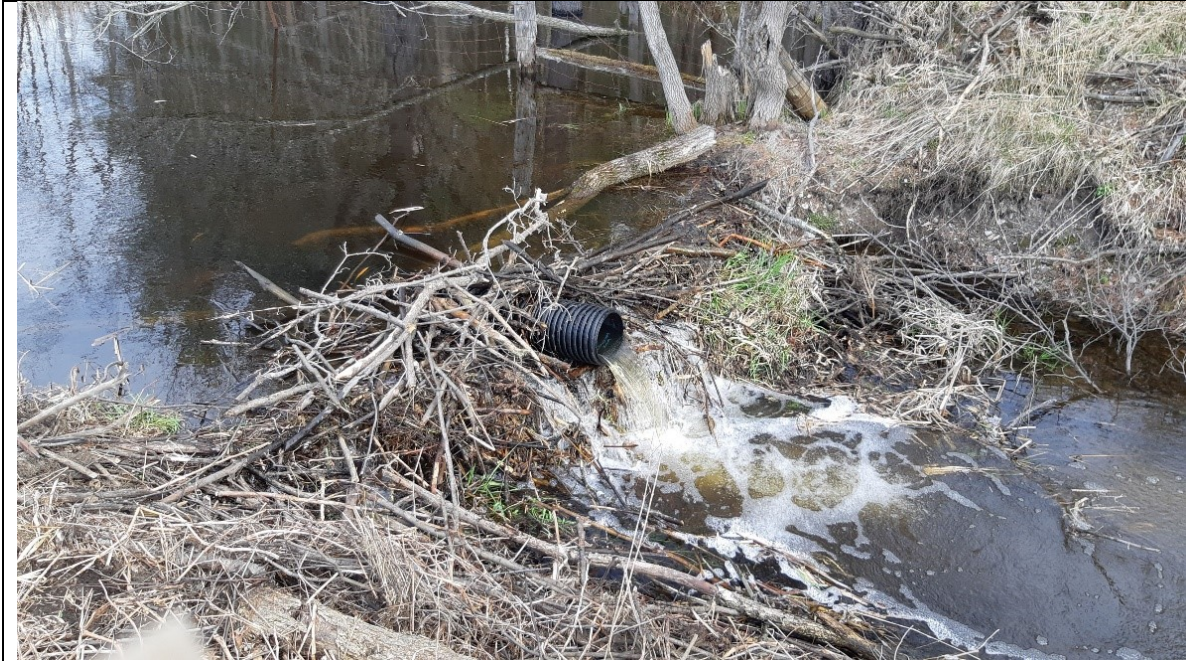
Photo 39: Water flow out of the pipe on initial set-up.

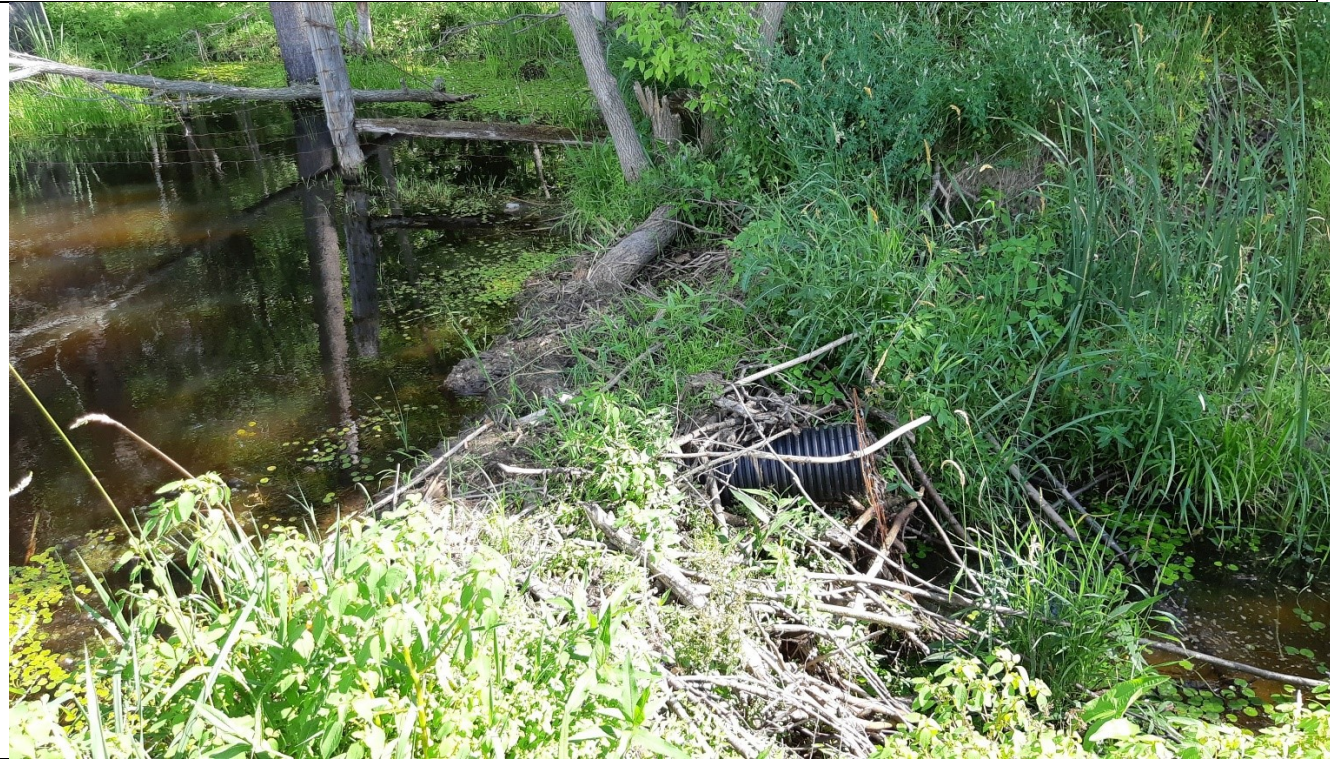
Photo 40: No water flow from pipe on July 4<sup>th</sup>, 2019.

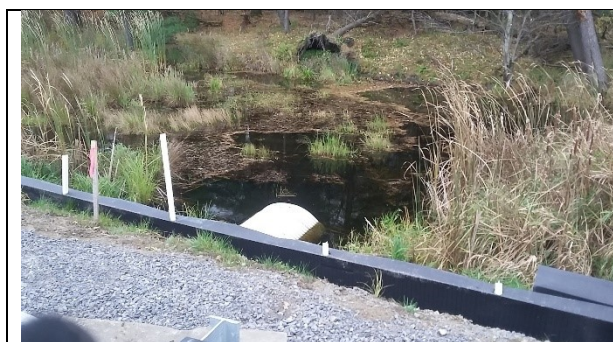
Photo 41: Exclusion fencing pulled 1 metre above south main culvert on higher ground

The amount of time animals move along exclusionary fence should be minimized. Previous research has shown that animals may be exposed to a fatality when moving along exclusionary fencing due to over-heating. In addition, if holes or fence gaps are present, animals will cross the road and be exposed to road-kill. These unnecessary fatalities can be prevented by providing shade structures such as shrubs along the safe-side of the fence, and ensuring there is adequate safe crossing opportunities such as culverts with guide-fencing (Peaden et al. 2017; Boyle et al. 2019).

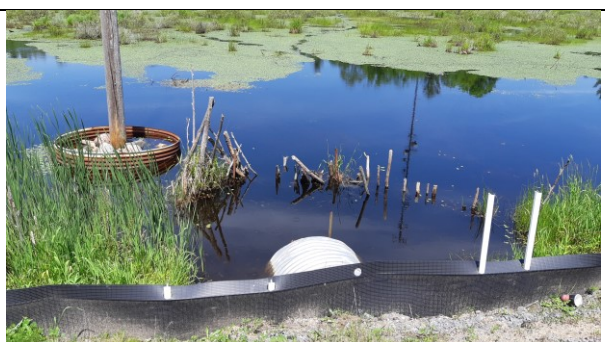
Photo 42: Exclusion fencing pulled 1 metre above north main culvert on higher ground

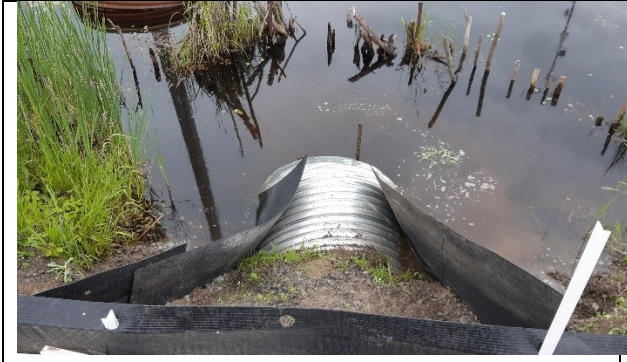
Photo 43: Guide-wall fencing extending from fence to north main culvert entrance on 13-Jun-19.
