# Ministry of Transportation of Ontario

## Highway Infrastructure Innovation Funding Program 2015 to 2019

### **Specific Topic #14: Beaver Exclusion-Turtle Passage & Reptile Exclusionary Fence Concept Designs: Literature Review and Field Testing**

**14-Jun-2020  
FINAL**

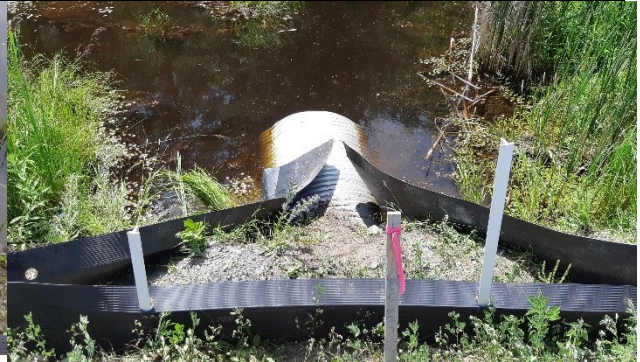
Photo 44: Guide-wall fencing extending from fence to south main entrance on 08-Jul-19

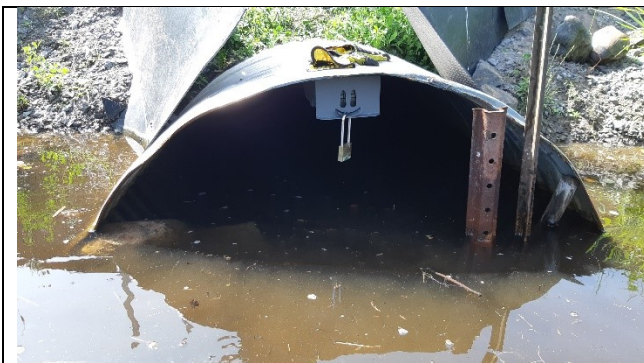
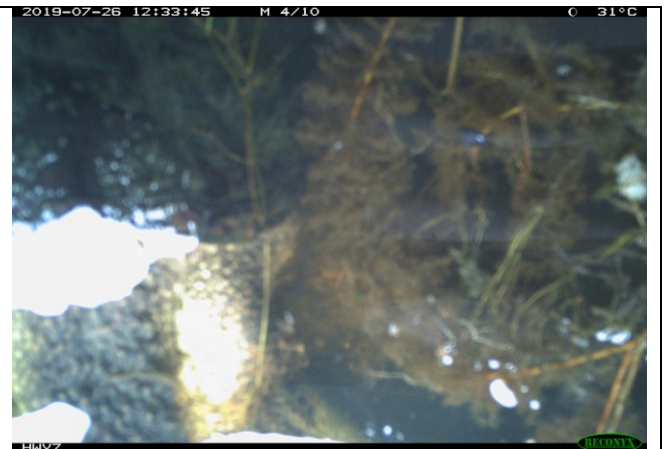
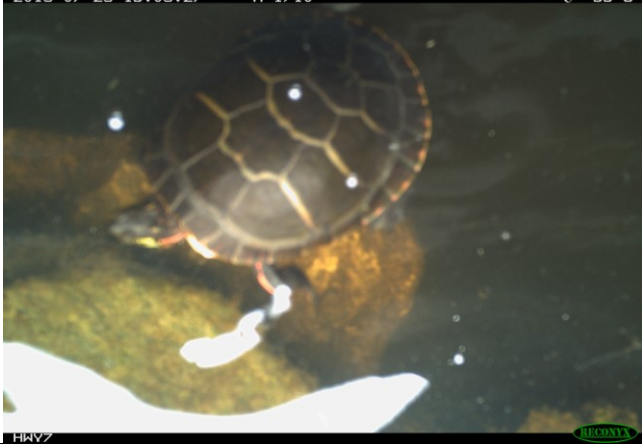
<p>Photo 45: Placement of camera in main culvert with rocks piled up to water height July 8<sup>th</sup>, 2019 (top); Painted Turtle passing under the camera field-of-view on the north side of the main drainage culvert on 29-Jul-19, at 13:09 PM (below).</p>	<p>Photo 46: Snapping Turtle passing under the camera field of view on the north side of the main drainage culvert on 26-Jul-19 at 12:26 PM.</p>

One motion triggered Reconyx camera (Hyperfire 2 HP2X) was used for monitoring on the north side of the culvert from July 8<sup>th</sup>, 2019 to September 20<sup>th</sup>, 2019. Monitoring was initiated when water levels receded enough to allow a camera to be placed on-top of the culvert, above water. Rocks were placed on-top of each other inside the culvert up to the high level of water which forced animals entering into the culvert to swim up into the camera field of view (Photo 45 top).

Among other aquatic mammals such as Muskrats, a Painted Turtle (Photo 45 bottom) and a Snapping Turtle (Photo 46) were documented using the main drainage culvert. Although only captured on one side of the culvert, the turtles were not seen turning around and are therefore likely complete passages (Eco-Kare International 2020). These two turtle passages highly support the success of the beaver-exclusion, turtle passage system as well as the new upsized culvert. If monitoring had been done in June, it is likely many more turtles would have been captured. Furthermore, it is likely that some turtles were missed because motion detection cameras are not ideal for cold-blooded animals and time lapse is ideal (Eco-Kare International 2020).

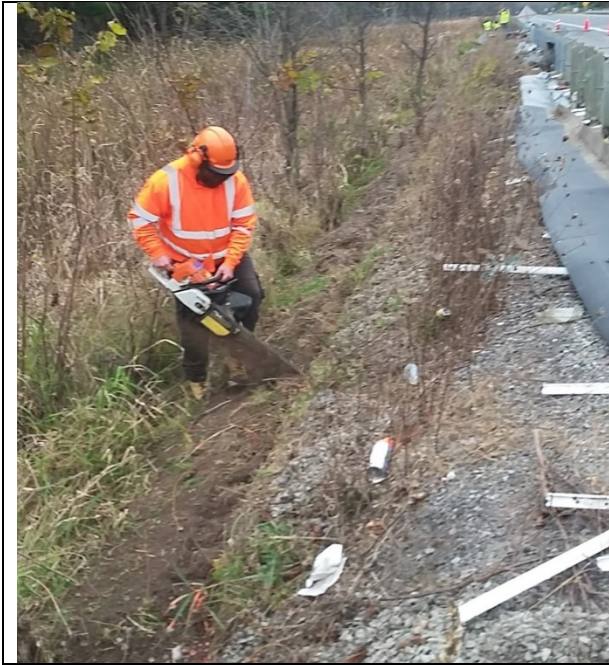
Photo 47: Preparation of ground at road slope for below-grade installation of exclusion fence, 23-Oct-18

In August 2016, it was decided that the entire fence would be replaced (Phase II), with a new below-grade installation with specialized joins between rolls of materials, (see <https://s3-eu-west-1.amazonaws.com/assets-animexfencing-com/documents/PDFs/Animex-Roadside-Embankment-Installation-Guide.pdf>; Photos 47-50). Furthermore, stronger and larger posts (5 cm wide) were used and attached to the fence by placing posts through holes drilled with a hole saw. Phase II installation began in August 2016 (100 m) and continued again in October 2018 (430 m). The remaining 36% of the phase I exclusion fence remains to be replaced on the south side of the highway.

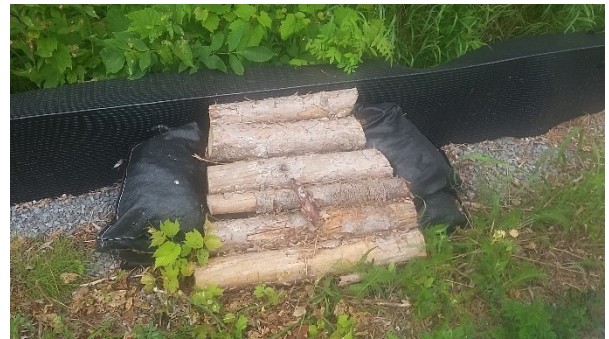
Photo 48: Example of a jump-out with wood pieces stacked and stabilized with sand bags in Presqu'île Provincial Park.

It is recommended to monitor this site to evaluate whether more animals are road-killed as a result of being trapped between the exclusion fence. In addition, jump-outs can be installed from woody debris piled up on the road-side of the fence to provide escape opportunities from the road-side of the fence. Jump-outs should be located at fence-ends or where the exclusion fence is a barrier to animal movement on the road-side (Photo 48). Alternatively, fine gravel or small rocks and dirt can be added to the back-side of the fence to make it level with the road-side slope.

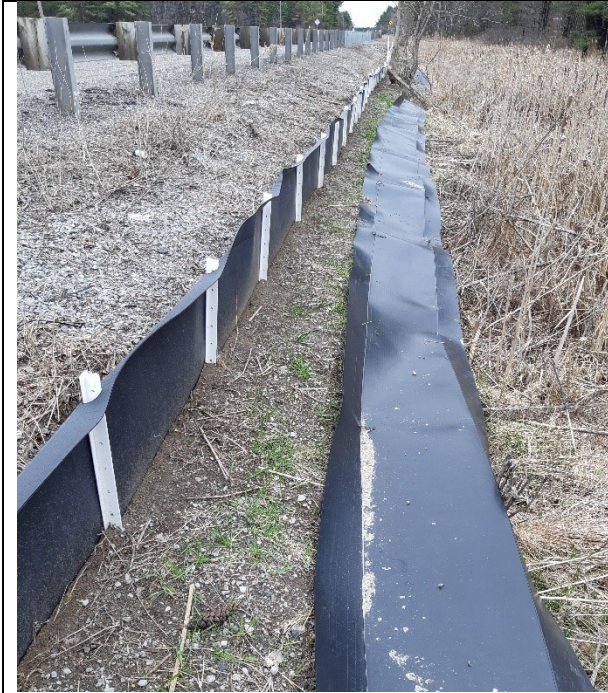
Photo 49: Viewing exclusion fence (Animex) from inside with larger stronger posts attached through the top lip of the fence 26-April-2019; no maintenance required after installation in October 2018.

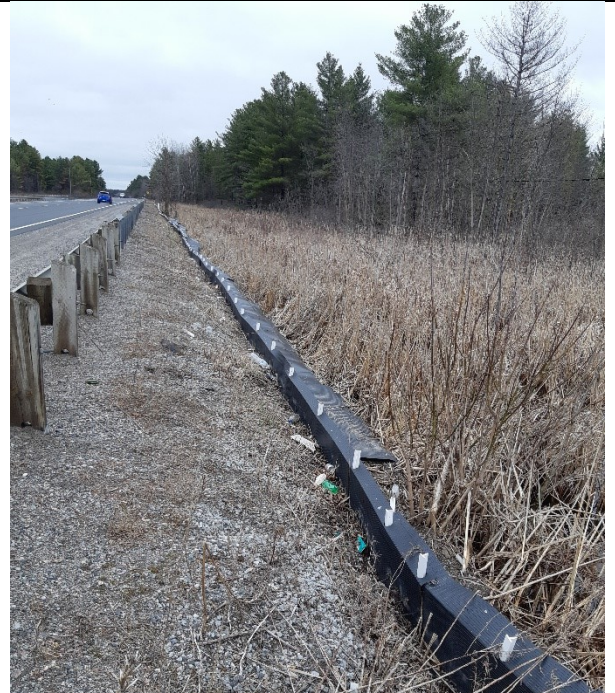
Photo 50: Viewing exclusion fence from top showing an approximate 30 cm below-grade installation (26-April-2019).

There were no new jump-outs or escape opportunities installed because about 75% of the fence height was below-grade and about 20-30 cm was above-grade. It is assumed that most small mammals and turtles could scale the 20-30 cm above-grade fencing. However, two dead beavers were found along-side the exclusion fence in 2017 and in 2019 (Photo 35). It is unknown whether these animals were road-killed or died of other causes.
